# Access Compliance Report

## Public Rights-of-Way

Intersection ID: 12826	Main Street: E_5TH_ST	Cross Street: N_ALEXANDER_ST	Location: N
ADA ID: 6F953DF4595D	Ramp Type: PerpDiag	Initial Pass/Fail: Fail	Overall Compliance: No
			Severity Score: 48.75

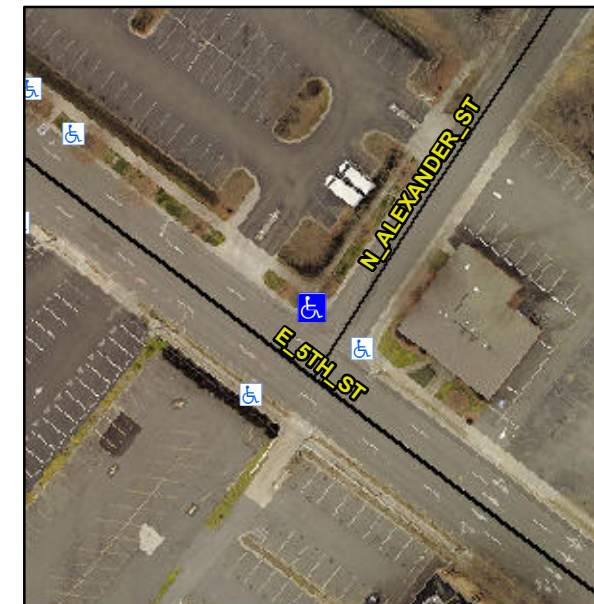
Compliance	Description	Data	Compliance	Description	Data
N/A	Ramp Length (in)	60.0	No	Ramp Slope (%)	9.0
No	Ramp Width (in)	28.0	No	Ramp XSlope (%)	3.1
N/A	Flare Type LT	N/A	N/A	Flare Type RT	N/A
N/A	Flare Slope LT (%)	N/A	N/A	Flare Slope RT (%)	N/A
N/A	Flare Traversable LT?	N/A	N/A	Flare Traversable RT?	N/A
N/A	Landing Length (in)	N/A	N/A	DWS Provided?	N/A
N/A	Landing Width (in)	N/A	N/A	DWS Contrast?	N/A
N/A	Landing Slope (%)	N/A	N/A	DWS Length (in)	N/A
N/A	Landing X Slope (%)	N/A	N/A	DWS Full Width?	N/A
N/A	Landing Curb? (Y/N)	N/A	N/A	DWS Offset (in)	N/A
N/A	Shared Landing?	N/A			
N/A	Gutter Ponding?	N/A	N/A	Gutter Slope (%)	N/A
N/A	Gutter Lip Ht (in)	N/A	N/A	Gutter X Slope (%)	N/A
N/A	Painted X Walk1?	No	N/A	Painted X Walk2?	No
	X Walk 1 Direction	To SW		X Walk 2 Direction	To SE
N/A	X Walk 1 Width (in)	N/A	N/A	X Walk 2 Width (in)	N/A
	X Walk 1 Slope (%)	4.5		X Walk 2 Slope (%)	1.3
	X Walk 1 X Slope (%)	1.6		X Walk 2 X Slope (%)	0.7

N/A	Ramp inside XWalk1?	N/A	N/A	Ramp inside XWalk2?	N/A
	Road Slope (%)	1.8	N/A	Clear Space?	N/A
	Road X Slope (%)	1.0	N/A	Clear Space to XWalk (in)	N/A
N/A	Any Obstructions?	N/A	N/A	Storm Grate/Utility Hazard?	N/A
	Obstruction Type			Storm Grate/Utility Type	
		N/A			N/A
			Yes	Surface Condition? (G/P)	Good

**Remove & Replace Curb Ramp With Two New Directional Ramps or Equivalent.**

**R304.5.1, R304.2.2, R304.5.3**
