Access Compliance Report

Public Rights-of-Way

(Curb Ramps)

Intersection ID: 10021099	Main Street: BEVERLY_CREST_BV	Cross Street: N/A	Location: NE
ADA ID: 6F9D53695DB0	Ramp Type: BlendTrans1	Initial Pass/Fail: Fail	Overall Compliance: No
Codes/Mitigation Info/Possible Solution			Severity Score: 25
Field Measurements/Component Compliance

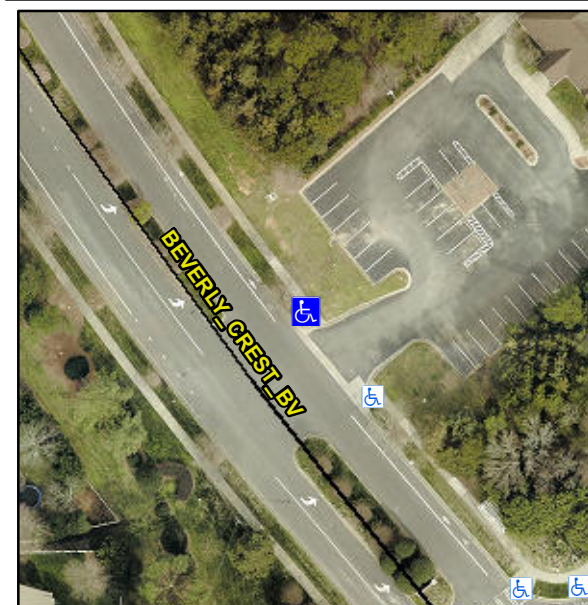
Compliance	Description	Data	Compliance	Description	Data
N/A	Ramp Length (in)	48.0	Yes	BlendTrans Slope (%)	2.3
Yes	Ramp Width (in)	48.0	No	BlendTrans XSlope (%)	12.8
N/A	Flare Type LT	N/A	N/A	Flare Type RT	N/A
N/A	Flare Slope LT (%)	N/A	N/A	Flare Slope RT (%)	N/A
N/A	Flare Traversable LT?	N/A	N/A	Flare Traversable RT?	N/A
N/A	Landing Length (in)	N/A	N/A	DWS Provided?	N/A
N/A	Landing Width (in)	N/A	N/A	DWS Contrast?	N/A
N/A	Landing Slope (%)	N/A	N/A	DWS Length (in)	N/A
N/A	Landing X Slope (%)	N/A	N/A	DWS Full Width?	N/A
N/A	Landing Curb? (Y/N)	N/A	N/A	DWS Offset (in)	N/A
N/A	Shared Landing?	N/A			
N/A	Gutter Ponding?	N/A	N/A	Gutter Slope (%)	N/A
N/A	Gutter Lip Ht (in)	N/A	N/A	Gutter X Slope (%)	N/A
N/A	Painted X Walk1?	No	N/A	Painted X Walk2?	No
	X Walk 1 Direction	To SW		X Walk 2 Direction	To SE
	X Walk 1 Width (in)	N/A		X Walk 2 Width (in)	N/A
	X Walk 1 Slope (%)	3.8		X Walk 2 Slope (%)	4.5
	X Walk 1 X Slope (%)	5.5		X Walk 2 X Slope (%)	6.0

N/A	Ramp inside XWalk1?	N/A	N/A	Ramp inside XWalk2?	N/A
	Road Slope (%)	11.1		Clear Space?	N/A
	Road X Slope (%)	0.3	N/A	Clear Space to XWalk (in)	N/A
N/A	Any Obstructions?	N/A	N/A	Storm Grate/Utility Hazard?	N/A
	Obstruction Type			Storm Grate/Utility Type	
		N/A			N/A
			Yes	Surface Condition? (G/P)	Good
			N/A	Curb Slope (%)	5.0

Possible Solutions:

Remove & Replace Curb Ramp With Two New Directional Ramps or Equivalent.

R304.5.3
