Access Compliance Report

Public Rights-of-Way

(Curb Ramps)

Intersection ID: 12704	Main Street: E_5TH_ST	Cross Street: N_DAVIDSON_ST	Location: S
ADA ID: 6F9DFCDFDB3A	Ramp Type: PerpDiag	Initial Pass/Fail: Fail	Overall Compliance: No
		Severity Score: 37.5

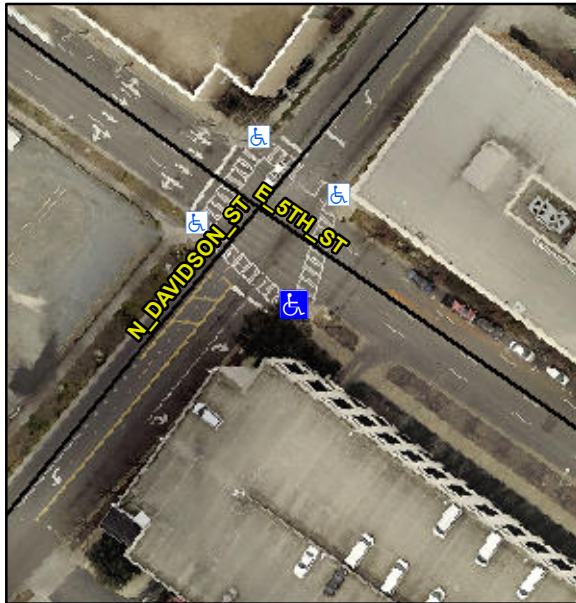
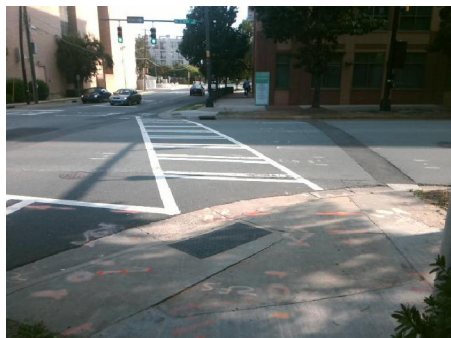
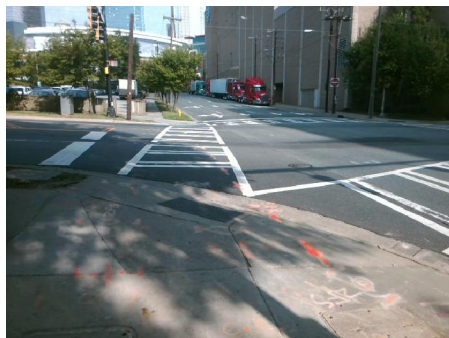
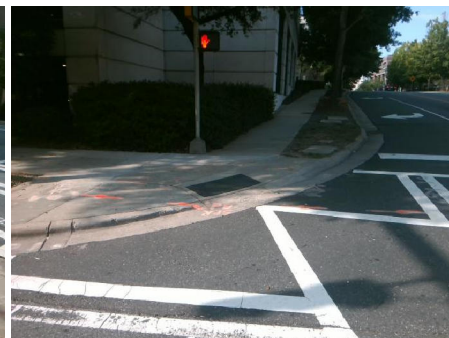
Not Found, R304.2.2, R304.5.3

Compliance	Description	Data	Compliance	Description	Data
N/A	Ramp Length (in)	37.0	No	Ramp Slope (%)	8.9
Yes	Ramp Width (in)	52.0	No	Ramp XSlope (%)	9.6
N/A	Flare Type LT	N/A	N/A	Flare Type RT	N/A
N/A	Flare Slope LT (%)	N/A	N/A	Flare Slope RT (%)	N/A
N/A	Flare Traversable LT?	N/A	N/A	Flare Traversable RT?	N/A
N/A	Landing Length (in)	N/A	N/A	DWS Provided?	N/A
N/A	Landing Width (in)	N/A	N/A	DWS Contrast?	N/A
N/A	Landing Slope (%)	N/A	N/A	DWS Length (in)	N/A
N/A	Landing X Slope (%)	N/A	N/A	DWS Full Width?	N/A
N/A	Landing Curb? (Y/N)	N/A	N/A	DWS Offset (in)	N/A
N/A	Shared Landing?	N/A			
N/A	Gutter Ponding?	N/A	N/A	Gutter Slope (%)	N/A
N/A	Gutter Lip Ht (in)	N/A	N/A	Gutter X Slope (%)	N/A
N/A	Painted X Walk1?	Yes	N/A	Painted X Walk2?	Yes
	X Walk 1 Direction	To NE		X Walk 2 Direction	To NW
N/A	X Walk 1 Width (in)	110.0	N/A	X Walk 2 Width (in)	99.0
	X Walk 1 Slope (%)	0.8		X Walk 2 Slope (%)	3.8
	X Walk 1 X Slope (%)	7.2		X Walk 2 X Slope (%)	6.0

N/A	Ramp inside XWalk1?	No	N/A	Ramp inside XWalk2?	No
	Road Slope (%)	6.1	N/A	Clear Space?	N/A
	Road X Slope (%)	0.9	N/A	Clear Space to XWalk (in)	N/A
N/A	Any Obstructions?	N/A	N/A	Storm Grate/Utility Hazard?	N/A
	Obstruction Type			Storm Grate/Utility Type	
		N/A			N/A
			Yes	Surface Condition? (G/P)	Good

Remove & Replace Curb Ramp With Two New Directional Ramps or Equivalent. Restripe Crosswalk.
