Access Compliance Report Public Rights-of-Way (Curb Ramps)

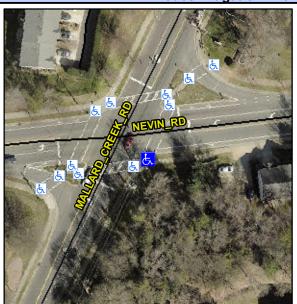
Intersection ID: 5741 Main Street: MALLARD_CREEK_RD Cross Street: NEVIN_RD Location: SE

1850.00

Field Measurements/Component Compliance						
Comp	liance Description	Data	Comp	liance Description	Data	
N/A	Ramp Length (in)	49.0	No	Ramp Slope (%)	13.5	
No	Ramp Width (in)	47.0	Yes	Ramp XSlope (%)	1.0	
N/A	Flare Type LT	N/A	N/A	Flare Type RT	N/A	
N/A	Flare Slope LT (%)	N/A	N/A	Flare Slope RT (%)	N/A	
N/A	Flare Traversable LT?	N/A	N/A	Flare Traversable RT?	N/A	
N/A	Landing Length (in)	N/A	N/A	DWS Provided?	N/A	
N/A	Landing Width (in)	N/A	N/A	DWS Contrast?	N/A	
N/A	Landing Slope (%)	N/A	N/A	DWS Length (in)	N/A	
N/A	Landing X Slope (%)	N/A	N/A	DWS Full Width?	N/A	
N/A	Landing Curb? (Y/N)	N/A	N/A	DWS Offset (in)	N/A	
N/A	Shared Landing?	N/A				
N/A	Gutter Ponding?	N/A	N/A	Gutter Slope (%)	N/A	
N/A	Gutter Lip Ht (in)	N/A	N/A	Gutter X Slope (%)	N/A	
N/A	Painted X Walk1?	Yes	N/A	Painted X Walk2?	N/A	
	X Walk 1 Direction	To NE		X Walk 2 Direction	N/A	
N/A	X Walk 1 Width (in)	158.0	N/A	X Walk 2 Width (in)	N/A	
	X Walk 1 Slope (%)	1.7		X Walk 2 Slope (%)	N/A

Street 1 Name	NEVIN RD
Stop Condition-Street 2	Signal
Street 2 Name	N/A
Ston Condition-Street 1	N/A
