Access Compliance Report

Public Rights-of-Way (Curb Ramps)

Intersection ID: 3973	Main Street: MALLARD_CREEK_RD	Cross Street: W_MALLARD_CREEK_CHURCH_RD	Location: N
ADA ID: 6FA91245FE08	Ramp Type: Perp	Initial Pass/Fail: Pass	Overall Compliance: No
Severity Score: 7.5			
Codes/Mitigation Info/Possible Solution		Field Measurements/Component Compliance

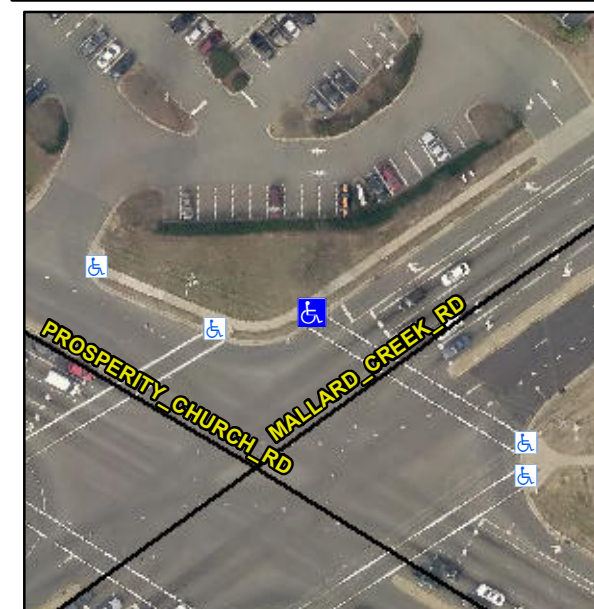
Compliance	Description	Data	Compliance	Description	Data
N/A	Ramp Length (in)	60.0	Yes	Ramp Slope (%)	7.2
Yes	Ramp Width (in)	49.0	Yes	Ramp XSlope (%)	0.0
N/A	Flare Type LT	Sloped	N/A	Flare Type RT	N/A
N/A	Flare Slope LT (%)	6.6	Yes	Flare Slope RT (%)	4.0
N/A	Flare Traversable LT?	Yes	N/A	Flare Traversable RT?	Yes
Yes	Landing Length (in)	60.0	Yes	DWS Provided?	Yes
Yes	Landing Width (in)	48.5	Yes	DWS Contrast?	Yes
Yes	Landing Slope (%)	1.3	Yes	DWS Length (in)	24.0
Yes	Landing X Slope (%)	1.1	Yes	DWS Full Width?	Yes
N/A	Landing Curb? (Y/N)	No	Yes	DWS Offset (in)	2.0
N/A	Shared Landing?	No			
Yes	Gutter Ponding?	No	Yes	Gutter Slope (%)	4.6
No	Gutter Lip Ht (in)	0.5	Yes	Gutter X Slope (%)	1.2
N/A	Painted X Walk1?	Yes	N/A	Painted X Walk2?	N/A
	X Walk 1 Direction	To SE		X Walk 2 Direction	N/A
N/A	X Walk 1 Width (in)	118.0	N/A	X Walk 2 Width (in)	N/A
	X Walk 1 Slope (%)	1.4		X Walk 2 Slope (%)	N/A
	X Walk 1 X Slope (%)	4.2		X Walk 2 X Slope (%)	N/A

Yes	Ramp inside XWalk1?	Yes	N/A	Ramp inside XWalk2?	N/A
	Road Slope (%)	N/A	N/A	Clear Space?	Yes
	Road X Slope (%)	N/A	N/A	Clear Space to XWalk (in)	N/A
Yes	Any Obstructions?	No	Yes	Storm Grate/Utility Hazard?	No
	Obstruction Type			Storm Grate/Utility Type	
		N/A			N/A
			Yes	Surface Condition? (G/P)	Good

Possible Solutions:

Grind Gutter Lip.

R302.7.2
