Access Compliance Report

Public Rights-of-Way

(Curb Ramps)

Intersection ID: 17696	Main Street: DENON_HILLS_DR	Cross Street: E W T HARRIS BV	Location: NE
ADA ID: 6FACEF1F96D1	Ramp Type: PerpDiag	Initial Pass/Fail: Fail	Overall Compliance: No
Severity Score: 21.25			
Codes/Mitigation Info/Possible Solution		Field Measurements/Component Compliance

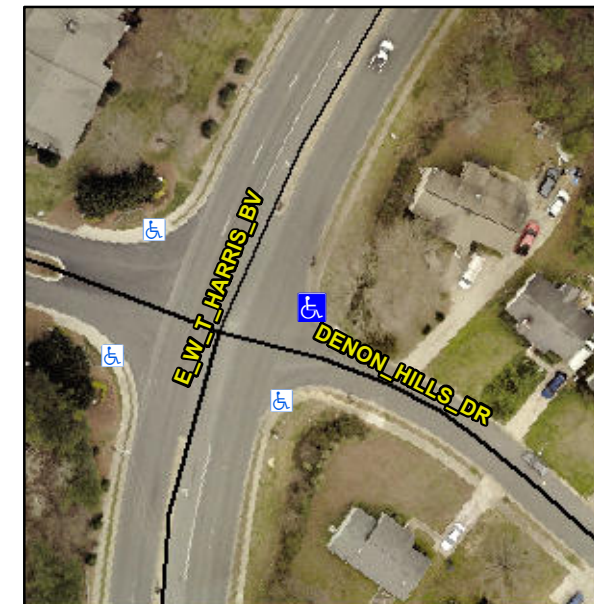
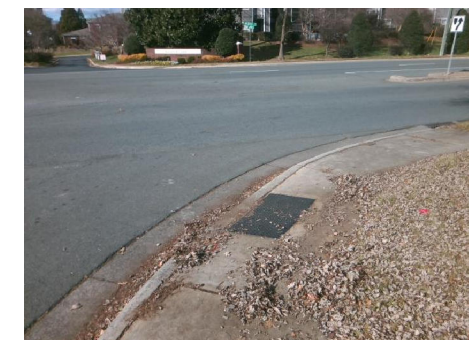
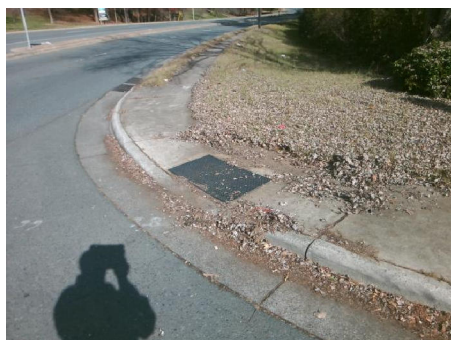
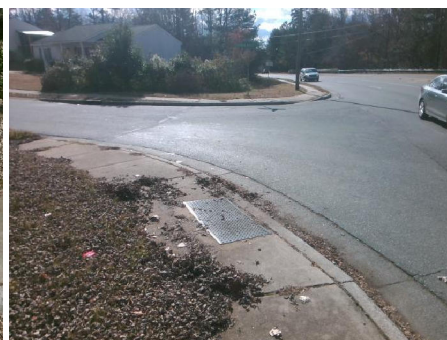
Not Found, R304.5.1, R304.5.3

Compliance	Description	Data	Compliance	Description	Data
N/A	Ramp Length (in)	56.5	Yes	Ramp Slope (%)	6.1
No	Ramp Width (in)	36.0	No	Ramp XSlope (%)	5.7
N/A	Flare Type LT	N/A	N/A	Flare Type RT	N/A
N/A	Flare Slope LT (%)	N/A	N/A	Flare Slope RT (%)	N/A
N/A	Flare Traversable LT?	N/A	N/A	Flare Traversable RT?	N/A
N/A	Landing Length (in)	N/A	N/A	DWS Provided?	N/A
N/A	Landing Width (in)	N/A	N/A	DWS Contrast?	N/A
N/A	Landing Slope (%)	N/A	N/A	DWS Length (in)	N/A
N/A	Landing X Slope (%)	N/A	N/A	DWS Full Width?	N/A
N/A	Landing Curb? (Y/N)	N/A	N/A	DWS Offset (in)	N/A
N/A	Shared Landing?	N/A			
N/A	Gutter Ponding?	N/A	N/A	Gutter Slope (%)	N/A
N/A	Gutter Lip Ht (in)	N/A	N/A	Gutter X Slope (%)	N/A
N/A	Painted X Walk1?	No	N/A	Painted X Walk2?	No
	X Walk 1 Direction	To NW		X Walk 2 Direction	To SW
N/A	X Walk 1 Width (in)	N/A	N/A	X Walk 2 Width (in)	N/A
	X Walk 1 Slope (%)	2.6		X Walk 2 Slope (%)	0.2
	X Walk 1 X Slope (%)	1.3		X Walk 2 X Slope (%)	0.1

N/A	Ramp inside XWalk1?	N/A	N/A	Ramp inside XWalk2?	N/A
	Road Slope (%)	0.1	N/A	Clear Space?	N/A
	Road X Slope (%)	1.6	N/A	Clear Space to XWalk (in)	N/A
N/A	Any Obstructions?	N/A	N/A	Storm Grate/Utility Hazard?	N/A
	Obstruction Type			Storm Grate/Utility Type	
		N/A			N/A
			Yes	Surface Condition? (G/P)	Good

Remove & Replace Curb Ramp With Two New Directional Ramps or Equivalent.
