# Access Compliance Report

## Public Rights-of-Way

### (Curb Ramps)

Intersection ID: 45544	Main Street: HARRIER_RD	Cross Street: CORNIELLE_LN	Location: SW
ADA ID: 6FB787F76753	Ramp Type: Perp	Initial Pass/Fail: Fail	Overall Compliance: No
Codes/Mitigation Info/Possible Solution		Field Measurements/Component Compliance	
Severity Score: 13.75

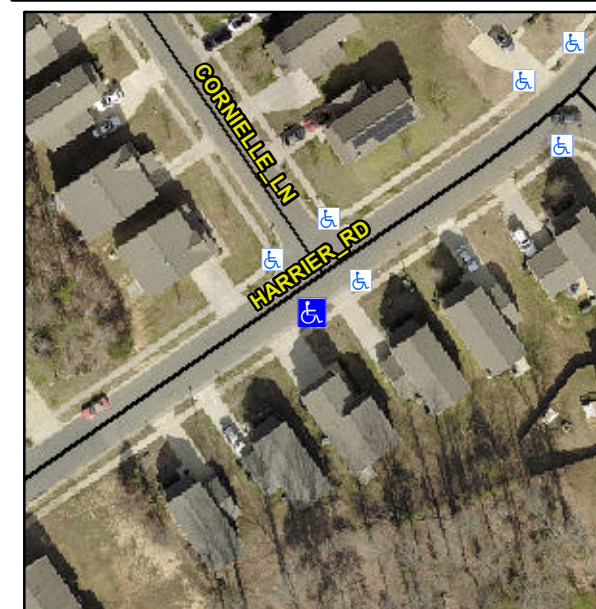
**Not Found, R304.2.2**

Compliance	Description	Data	Compliance	Description	Data
N/A	Ramp Length (in)	46.5	No	Ramp Slope (%)	9.3
Yes	Ramp Width (in)	48.0	Yes	Ramp XSlope (%)	2.3
N/A	Flare Type LT	N/A	N/A	Flare Type RT	N/A
N/A	Flare Slope LT (%)	N/A	N/A	Flare Slope RT (%)	N/A
N/A	Flare Traversable LT?	N/A	N/A	Flare Traversable RT?	N/A
N/A	Landing Length (in)	N/A	N/A	DWS Provided?	N/A
N/A	Landing Width (in)	N/A	N/A	DWS Contrast?	N/A
N/A	Landing Slope (%)	N/A	N/A	DWS Length (in)	N/A
N/A	Landing X Slope (%)	N/A	N/A	DWS Full Width?	N/A
N/A	Landing Curb? (Y/N)	N/A	N/A	DWS Offset (in)	N/A
N/A	Shared Landing?	N/A			
N/A	Gutter Ponding?	N/A	N/A	Gutter Slope (%)	N/A
N/A	Gutter Lip Ht (in)	N/A	N/A	Gutter X Slope (%)	N/A
N/A	Painted X Walk1?	No	N/A	Painted X Walk2?	N/A
	X Walk 1 Direction	To N		X Walk 2 Direction	N/A
N/A	X Walk 1 Width (in)	N/A	N/A	X Walk 2 Width (in)	N/A
	X Walk 1 Slope (%)	1.3		X Walk 2 Slope (%)	N/A
	X Walk 1 X Slope (%)	3.6		X Walk 2 X Slope (%)	N/A

N/A	Ramp inside XWalk1?	N/A	N/A	Ramp inside XWalk2?	N/A
	Road Slope (%)	N/A	N/A	Clear Space?	N/A
	Road X Slope (%)	N/A	N/A	Clear Space to XWalk (in)	N/A
N/A	Any Obstructions?	N/A	N/A	Storm Grate/Utility Hazard?	N/A
	Obstruction Type			Storm Grate/Utility Type	
		N/A			N/A
			Yes	Surface Condition? (G/P)	Good

**Remove & Replace Entire Ramp.**

Total Cost: \$ 1850.00
