## **Access Compliance Report Public Rights-of-Way** (Curb Ramps)

Intersection ID: 43512 Main Street: BLUEBERRY HOLLOW PL Cross Street: VICTORIA\_BROOK\_LN Location:

ADA ID: 6FB85B5A1681 Ramp Type: Perp Initial Pass/Fail: Fail **Overall Compliance: No** Severity Score: 46.25

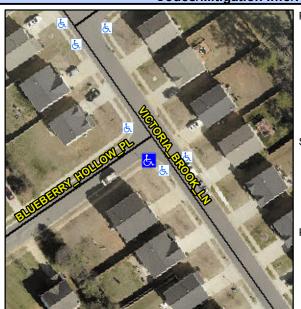
Field Measurements/Component Compliance						
	Compliance Description		Data	Compliance Description		Data
	N/A	Ramp Length (in)	48.0	No	Ramp Slope (%)	9.0
	No	Ramp Width (in)	47.0	No	Ramp XSlope (%)	7.1
	N/A	Flare Type LT	N/A	N/A	Flare Type RT	N/A
	N/A	Flare Slope LT (%)	N/A	N/A	Flare Slope RT (%)	N/A
	N/A	Flare Traversable LT?	N/A	N/A	Flare Traversable RT?	N/A
	N/A	Landing Length (in)	N/A	N/A	DWS Provided?	N/A
	N/A	Landing Width (in)	N/A	N/A	DWS Contrast?	N/A
	N/A	Landing Slope (%)	N/A	N/A	DWS Length (in)	N/A
	N/A	Landing X Slope (%)	N/A	N/A	DWS Full Width?	N/A
	N/A	Landing Curb? (Y/N)	N/A	N/A	DWS Offset (in)	N/A
	N/A	Shared Landing?	N/A			
	N/A	Gutter Ponding?	N/A	N/A	Gutter Slope (%)	N/A
	N/A	Gutter Lip Ht (in)	N/A	N/A	Gutter X Slope (%)	N/A
	N/A	Painted X Walk1?	No	N/A	Painted X Walk2?	N/A
		X Walk 1 Direction	To N		X Walk 2 Direction	N/A
	N/A	X Walk 1 Width (in)	N/A	N/A	X Walk 2 Width (in)	N/A
		X Walk 1 Slope (%)	2.2		X Walk 2 Slope (%)	N/A

X Walk 1 X Slope (%)	1.7		X Walk 2 X Slope (%)	N/A
	N/A	Ramp inside XWalk1?	N/A	N/A	Ramp inside XWalk2?	N/A
		Road Slope (%)	N/A	N/A	Clear Space?	N/A
		Road X Slope (%)	N/A	N/A	Clear Space to XWalk (in)	N/A
	N/A	Any Obstructions?	N/A	N/A	Storm Grate/Utility Hazard?	N/A
		Obstruction Type			Storm Grate/Utility Type	
			N/A			N/A
				Yes	Surface Condition? (G/P)	Good
T	MEN A	HIII / William

Possible Solutions: Remove & Replace Entire Ramp. Surveyor Notes: N/A PROW/ADA: Not Found, R304.5.1, R304.2.2, R304.5.3
