## Access Compliance Report Public Rights-of-Way (Curb Ramps)

Intersection ID: 44215 Main Street: NATIONS\_FORD\_RD Cross Street: TYVOLA\_GLEN\_CR Location: E

ADA ID: 6FBF4B3D2F63 Ramp Type: ParaDiag Initial Pass/Fail: Fail Overall Compliance: No Severity Score: 13.75

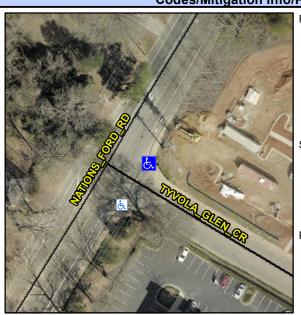
Compliance Description Data		Compliance Description		Data	
N/A	Ramp Length LT (in)	56.0	N/A	Ramp Length RT (in)	5.3
Yes	Ramp Width LT (in)	82.0	Yes	Ramp Width RT (in)	84.0
Yes	Ramp Slope LT (%)	7.1	No	Ramp Slope RT (%)	10.3
No	Ramp XSlope LT (%)	3.1	No	Ramp XSlope RT (%)	2.9
N/A	Landing Length (in)	N/A	N/A	DWS Provided?	N/A
N/A	Landing Width (in)	N/A	N/A	DWS Contrast?	N/A
N/A	Landing Slope (%)	N/A	N/A	DWS Length (in)	N/A
N/A	Landing X Slope (%)	N/A	N/A	DWS Full Width?	N/A
N/A	Landing Curb? (Y/N)	N/A	N/A	DWS Offset (in)	N/A
N/A	Shared Landing?	N/A			
N/A	Gutter Ponding?	N/A	N/A	Gutter Slope (%)	N/A
N/A	Gutter Lip Ht (in)	N/A	N/A	Gutter X Slope (%)	N/A
N/A	Painted X Walk1?	No	N/A	Painted X Walk2?	No
	X Walk 1 Direction	To NW		X Walk 2 Direction	To SW
N/A	X Walk 1 Width (in)	N/A	N/A	X Walk 2 Width (in)	N/A
	X Walk 1 Slope (%)	1.2		X Walk 2 Slope (%)	2.2
	X Walk 1 X Slope (%)	1.6		X Walk 2 X Slope (%)	0.2
N/A	Ramp inside XWalk1?	N/A	N/A	Ramp inside XWalk2?	N/A

Road Slope (%)	1.7	N/A	Clear Space?	N/A
	Road X Slope (%)	2.4	N/A	Clear Space to XWalk (in)	N/A
N/A	Any Obstructions?	N/A	N/A	Storm Grate/Utility Hazard?	N/A
	Obstruction Type			Storm Grate/Utility Type	
		N/A			N/A
			Yes	Surface Condition? (G/P)	Good
			N/A	Curb Slope (%)	7.3

Remove & Replace Curb Ramp With Two New Directional Ramps or Equivalent.

R304.5.3, R304.3.2
