Access Compliance Report

Public Rights-of-Way

(Curb Ramps)

| Intersection ID: 13641 | Main Street: BAY_ST | Cross Street: CLEMENT_AV | Location: E |

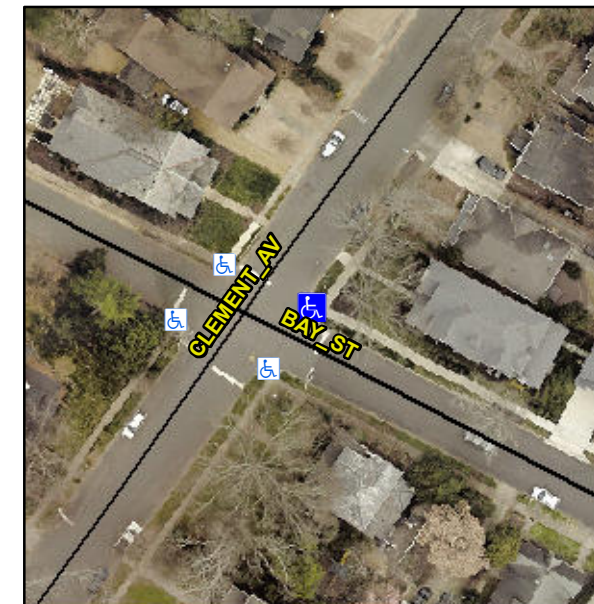
Not Found, R304.2.2

| Compliance | Description | Data | Compliance | Description | Data |
|---|---|---|---|---|---|
| N/A | Ramp Length (in) | 53.0 | No | Ramp Slope (%) | 9.0 |
| Yes | Ramp Width (in) | 130.0 | Yes | Ramp XSlope (%) | 0.8 |

Remove & Replace Curb Ramp With Two New Directional Ramps or Equivalent.
