# Access Compliance Report

## Public Rights-of-Way

### (Curb Ramps)

Intersection ID: 13541	Main Street: CENTRAL_AV	Cross Street: EASTCREST_DR	Location: NW
ADA ID: 6FC3F8D520C7	Ramp Type: Perp	Initial Pass/Fail: Fail	Overall Compliance: No
		Severity Score: 10

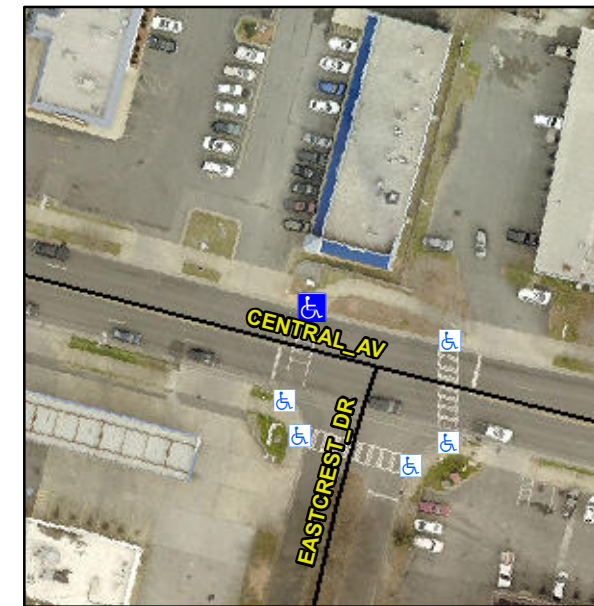
**Not Found, R304.5.1**

Compliance	Description	Data	Compliance	Description	Data
N/A	Ramp Length (in)	97.5	Yes	Ramp Slope (%)	6.3
No	Ramp Width (in)	47.5	Yes	Ramp XSlope (%)	3.8
N/A	Flare Type LT	N/A	N/A	Flare Type RT	N/A
N/A	Flare Slope LT (%)	N/A	N/A	Flare Slope RT (%)	N/A
N/A	Flare Traversable LT?	N/A	N/A	Flare Traversable RT?	N/A
N/A	Landing Length (in)	N/A	N/A	DWS Provided?	N/A
N/A	Landing Width (in)	N/A	N/A	DWS Contrast?	N/A
N/A	Landing Slope (%)	N/A	N/A	DWS Length (in)	N/A
N/A	Landing X Slope (%)	N/A	N/A	DWS Full Width?	N/A
N/A	Landing Curb? (Y/N)	N/A	N/A	DWS Offset (in)	N/A
N/A	Shared Landing?	N/A			
N/A	Gutter Ponding?	N/A	N/A	Gutter Slope (%)	N/A
N/A	Gutter Lip Ht (in)	N/A	N/A	Gutter X Slope (%)	N/A
N/A	Painted X Walk1?	Yes	N/A	Painted X Walk2?	N/A
	X Walk 1 Direction	To SW		X Walk 2 Direction	N/A
N/A	X Walk 1 Width (in)	111.0	N/A	X Walk 2 Width (in)	N/A
	X Walk 1 Slope (%)	4.2		X Walk 2 Slope (%)	N/A
	X Walk 1 X Slope (%)	3.9		X Walk 2 X Slope (%)	N/A

N/A	Ramp inside XWalk1?	Yes	N/A	Ramp inside XWalk2?	N/A
	Road Slope (%)	N/A	N/A	Clear Space?	N/A
	Road X Slope (%)	N/A	N/A	Clear Space to XWalk (in)	N/A
N/A	Any Obstructions?	N/A	N/A	Storm Grate/Utility Hazard?	N/A
	Obstruction Type			Storm Grate/Utility Type	
		N/A			N/A
		Yes		Surface Condition? (G/P)	Good

Possible Solutions:

**Remove & Replace Entire Ramp.**

Total Cost: \$ 1850.00
