Access Compliance Report

Public Rights-of-Way

(Curb Ramps)

Intersection ID: 10031842	Main Street: MINTWORTH_AV	Cross Street: N/A	Location: SW
ADA ID: 6FC90EE4C099	Ramp Type: Perp	Initial Pass/Fail: Fail	Overall Compliance: No
Severity Score: 1.25			
Codes/Mitigation Info/Possible Solution		Field Measurements/Component Compliance

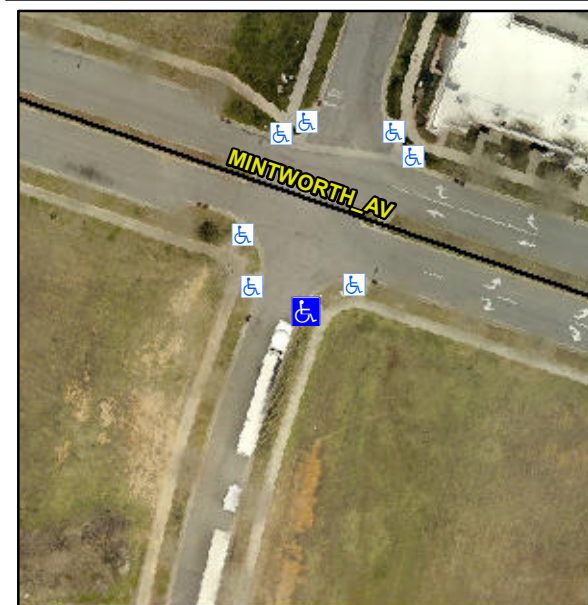
Not Found, R304.5.3

Compliance	Description	Data	Compliance	Description	Data
N/A	Ramp Length (in)	97.0	Yes	Ramp Slope (%)	8.1
Yes	Ramp Width (in)	48.0	No	Ramp XSlope (%)	4.1
N/A	Flare Type LT	N/A	N/A	Flare Type RT	N/A
N/A	Flare Slope LT (%)	N/A	N/A	Flare Slope RT (%)	N/A
N/A	Flare Traversable LT?	N/A	N/A	Flare Traversable RT?	N/A
N/A	Landing Length (in)	N/A	N/A	DWS Provided?	N/A
N/A	Landing Width (in)	N/A	N/A	DWS Contrast?	N/A
N/A	Landing Slope (%)	N/A	N/A	DWS Length (in)	N/A
N/A	Landing X Slope (%)	N/A	N/A	DWS Full Width?	N/A
N/A	Landing Curb? (Y/N)	N/A	N/A	DWS Offset (in)	N/A
N/A	Shared Landing?	N/A			
N/A	Gutter Ponding?	N/A	N/A	Gutter Slope (%)	N/A
N/A	Gutter Lip Ht (in)	N/A	N/A	Gutter X Slope (%)	N/A
N/A	Painted X Walk1?	No	N/A	Painted X Walk2?	N/A
	X Walk 1 Direction	To NW		X Walk 2 Direction	N/A
N/A	X Walk 1 Width (in)	N/A	N/A	X Walk 2 Width (in)	N/A
	X Walk 1 Slope (%)	1.3		X Walk 2 Slope (%)	N/A
	X Walk 1 X Slope (%)	3.8		X Walk 2 X Slope (%)	N/A

N/A	Ramp inside XWalk1?	N/A	N/A	Ramp inside XWalk2?	N/A
	Road Slope (%)	N/A	N/A	Clear Space?	N/A
	Road X Slope (%)	N/A	N/A	Clear Space to XWalk (in)	N/A
N/A	Any Obstructions?	N/A	N/A	Storm Grate/Utility Hazard?	N/A
	Obstruction Type			Storm Grate/Utility Type	
		N/A			N/A
			Yes	Surface Condition? (G/P)	Good

Possible Solutions:

Remove & Replace Entire Ramp.
