Access Compliance Report

Public Rights-of-Way

(Curb Ramps)

Intersection ID: 10033070	Main Street: NORTH_COMMUNITY_HOUSE_RD	Cross Street: N/A	Location: NW
ADA ID: 6FCC332E741C	Ramp Type: Perp	Initial Pass/Fail: Fail	Overall Compliance: No
Severity Score: 12.5			
Codes/Mitigation Info/Possible Solution		Field Measurements/Component Compliance

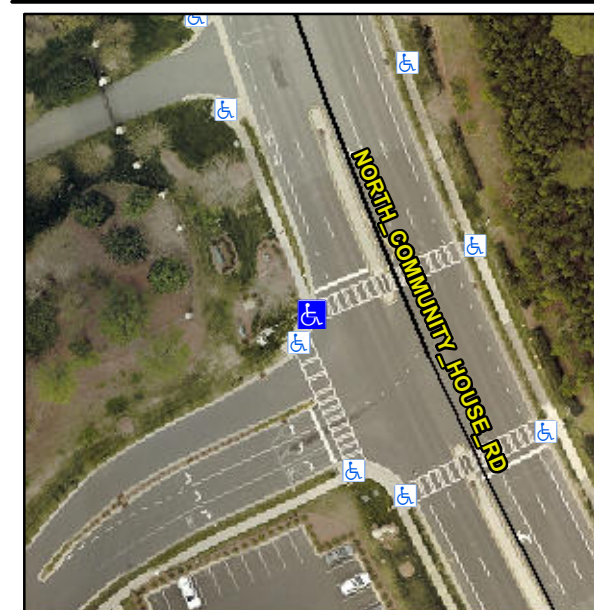
Compliance	Description	Data	Compliance	Description	Data
N/A	Ramp Length (in)	26.5	No	Ramp Slope (%)	11.0
Yes	Ramp Width (in)	48.0	Yes	Ramp XSlope (%)	1.8
N/A	Flare Type LT	N/A	N/A	Flare Type RT	N/A
N/A	Flare Slope LT (%)	N/A	N/A	Flare Slope RT (%)	N/A
N/A	Flare Traversable LT?	N/A	N/A	Flare Traversable RT?	N/A
N/A	Landing Length (in)	N/A	N/A	DWS Provided?	N/A
N/A	Landing Width (in)	N/A	N/A	DWS Contrast?	N/A
N/A	Landing Slope (%)	N/A	N/A	DWS Length (in)	N/A
N/A	Landing X Slope (%)	N/A	N/A	DWS Full Width?	N/A
N/A	Landing Curb? (Y/N)	N/A	N/A	DWS Offset (in)	N/A
N/A	Shared Landing?	N/A			
N/A	Gutter Ponding?	N/A	N/A	Gutter Slope (%)	N/A
N/A	Gutter Lip Ht (in)	N/A	N/A	Gutter X Slope (%)	N/A
N/A	Painted X Walk1?	Yes	N/A	Painted X Walk2?	N/A
	X Walk 1 Direction	To NE		X Walk 2 Direction	N/A
N/A	X Walk 1 Width (in)	109.0	N/A	X Walk 2 Width (in)	N/A
	X Walk 1 Slope (%)	2.9		X Walk 2 Slope (%)	N/A
	X Walk 1 X Slope (%)	2.1		X Walk 2 X Slope (%)	N/A

N/A	Ramp inside XWalk1?	Yes	N/A	Ramp inside XWalk2?	N/A
	Road Slope (%)	N/A	N/A	Clear Space?	N/A
	Road X Slope (%)	N/A	N/A	Clear Space to XWalk (in)	N/A
N/A	Any Obstructions?	N/A	N/A	Storm Grate/Utility Hazard?	N/A
	Obstruction Type			Storm Grate/Utility Type	
		N/A			N/A
		Yes		Surface Condition? (G/P)	Good

Possible Solutions:

Remove & Replace Entire Ramp.

R304.2.2

\$ 1850.00
