Access Compliance Report

Public Rights-of-Way

(Curb Ramps)

| Intersection ID: 30581 | Main Street: CIRCLEGREEN_DR | Cross Street: N/A | Location: NE |

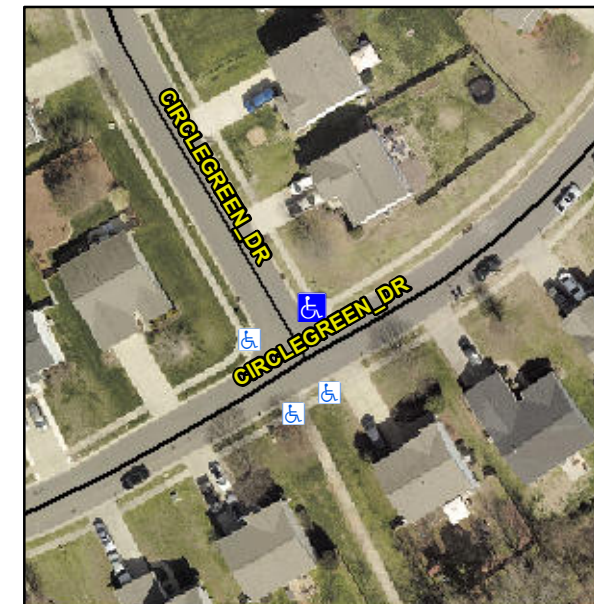
| ADA ID: 6FCC3CF3B3BA | Ramp Type: PerpDiag | Initial Pass/Fail: Fail | Overall Compliance: No |

Not Found, R304.5.3

| Compliance | Description | Data | Compliance | Description | Data |
|---|---|---|---|---|---|
| Yes | Ramp Width (in) | 48.0 | No | Ramp XSlope (%) | 7.5 |

Remove & Replace Curb Ramp With Two New Directional Ramps or Equivalent.

Total Cost: \$ 3200.00
