Access Compliance Report

Public Rights-of-Way

(Curb Ramps)

Intersection ID: N/A	Main Street: BRECKFIELD_CT	Cross Street: SHETLAND_LN	Location: SW
ADA ID: 6FD3E1B08754	Ramp Type: Perp	Initial Pass/Fail: Fail	Overall Compliance: No
		Severity Score: 12.5

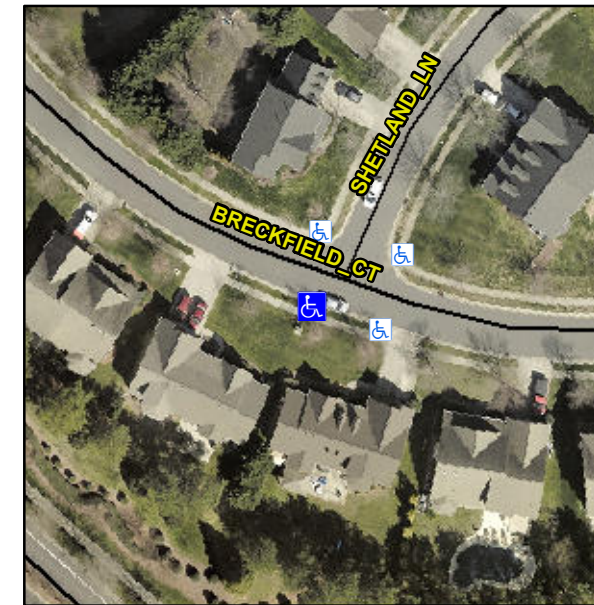
Not Found, R304.2.2

Compliance	Description	Data	Compliance	Description	Data
N/A	Ramp Length (in)	47.0	No	Ramp Slope (%)	8.6
Yes	Ramp Width (in)	48.0	Yes	Ramp XSlope (%)	0.2
N/A	Flare Type LT	N/A	N/A	Flare Type RT	N/A
N/A	Flare Slope LT (%)	N/A	N/A	Flare Slope RT (%)	N/A
N/A	Flare Traversable LT?	N/A	N/A	Flare Traversable RT?	N/A
N/A	Landing Length (in)	N/A	N/A	DWS Provided?	N/A
N/A	Landing Width (in)	N/A	N/A	DWS Contrast?	N/A
N/A	Landing Slope (%)	N/A	N/A	DWS Length (in)	N/A
N/A	Landing X Slope (%)	N/A	N/A	DWS Full Width?	N/A
N/A	Landing Curb? (Y/N)	N/A	N/A	DWS Offset (in)	N/A
N/A	Shared Landing?	N/A			
N/A	Gutter Ponding?	N/A	N/A	Gutter Slope (%)	N/A
N/A	Gutter Lip Ht (in)	N/A	N/A	Gutter X Slope (%)	N/A
N/A	Painted X Walk1?	No	N/A	Painted X Walk2?	N/A
	X Walk 1 Direction	To N		X Walk 2 Direction	N/A
N/A	X Walk 1 Width (in)	N/A	N/A	X Walk 2 Width (in)	N/A
	X Walk 1 Slope (%)	3.1		X Walk 2 Slope (%)	N/A
	X Walk 1 X Slope (%)	1.7		X Walk 2 X Slope (%)	N/A

N/A	Ramp inside XWalk1?	N/A	N/A	Ramp inside XWalk2?	N/A
	Road Slope (%)	N/A	N/A	Clear Space?	N/A
	Road X Slope (%)	N/A	N/A	Clear Space to XWalk (in)	N/A
N/A	Any Obstructions?	N/A	N/A	Storm Grate/Utility Hazard?	N/A
	Obstruction Type			Storm Grate/Utility Type	
		N/A			N/A
			Yes	Surface Condition? (G/P)	Good

Possible Solutions:

Remove & Replace Entire Ramp.

Total Cost: \$ 1850.00
