# Access Compliance Report

## Public Rights-of-Way

### (Curb Ramps)

| Intersection ID: 13352 | Main Street: S_ALEXANDER_ST | Cross Street: E_STONEWALL_ST | Location: SW |

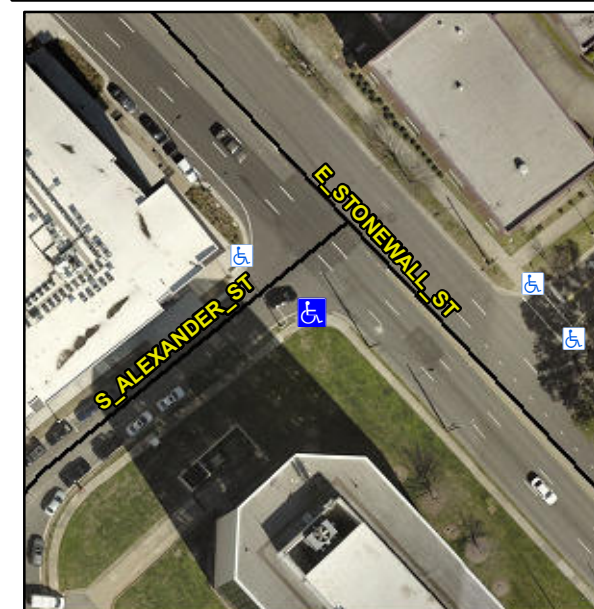
| ADA ID: 6FDEC9AAD0D3 | Ramp Type: ParaDiag | Initial Pass/Fail: Fail | Overall Compliance: No |
| Severity Score: 13.75 | | | |

**RT RP < 5%**

**R304.3.2, R304.5.3**

| Compliance | Description | Data | Compliance | Description | Data |
|---|---|---|---|---|---|
| No | Ramp Slope LT (%) | 9.4 | Yes | Ramp Slope RT (%) | 3.5 |
| No | Ramp XSlope LT (%) | 2.8 | Yes | Ramp XSlope RT (%) | 1.9 |

**Remove & Replace Curb Ramp With Two New Directional Ramps or Equivalent.**

Total Cost: \$ 3200.00
