Access Compliance Report

Public Rights-of-Way

(Curb Ramps)

Intersection ID: 14423	Main Street: ALBEMARLE_RD	Cross Street: HOLLIROSE_DR	Location: NE
ADA ID: 6FDF40FE19CC	Ramp Type: Perp	Initial Pass/Fail: Fail	Overall Compliance: No
Severity Score: 12.5			
Codes/Mitigation Info/Possible Solution		Field Measurements/Component Compliance

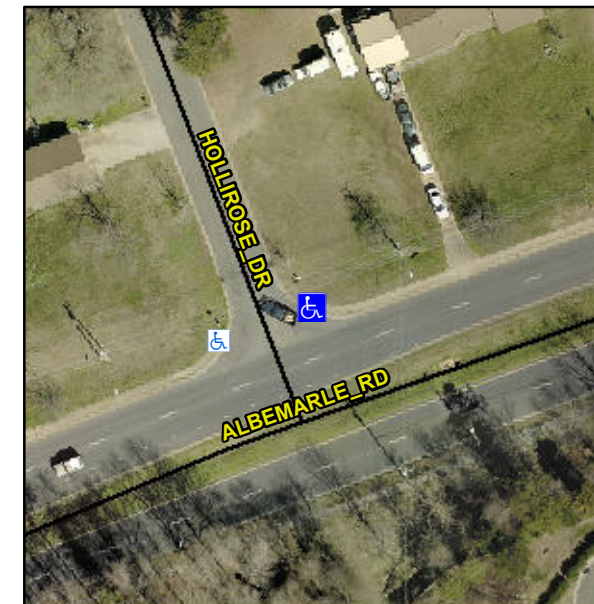
Not Found, R304.2.2

Compliance	Description	Data	Compliance	Description	Data
N/A	Ramp Length (in)	61.0	No	Ramp Slope (%)	10.2
Yes	Ramp Width (in)	48.0	Yes	Ramp XSlope (%)	1.4
N/A	Flare Type LT	N/A	N/A	Flare Type RT	N/A
N/A	Flare Slope LT (%)	N/A	N/A	Flare Slope RT (%)	N/A
N/A	Flare Traversable LT?	N/A	N/A	Flare Traversable RT?	N/A
N/A	Landing Length (in)	N/A	N/A	DWS Provided?	N/A
N/A	Landing Width (in)	N/A	N/A	DWS Contrast?	N/A
N/A	Landing Slope (%)	N/A	N/A	DWS Length (in)	N/A
N/A	Landing X Slope (%)	N/A	N/A	DWS Full Width?	N/A
N/A	Landing Curb? (Y/N)	N/A	N/A	DWS Offset (in)	N/A
N/A	Shared Landing?	N/A			
N/A	Gutter Ponding?	N/A	N/A	Gutter Slope (%)	N/A
N/A	Gutter Lip Ht (in)	1.5	N/A	Gutter X Slope (%)	N/A
N/A	Painted X Walk1?	No	N/A	Painted X Walk2?	N/A
	X Walk 1 Direction	To W		X Walk 2 Direction	N/A
N/A	X Walk 1 Width (in)	N/A	N/A	X Walk 2 Width (in)	N/A
	X Walk 1 Slope (%)	0.0		X Walk 2 Slope (%)	N/A
	X Walk 1 X Slope (%)	0.4		X Walk 2 X Slope (%)	N/A

Remove & Replace Entire Ramp.
