# Access Compliance Report

## Public Rights-of-Way

### (Curb Ramps)

Intersection ID: 32217	Main Street: REAVENCREST_PARK_DR	Cross Street: BRYANT_FARMS_RD	Location: NW
ADA ID: 6FE30D50448F	Ramp Type: PerpDiag	Initial Pass/Fail: Fail	Overall Compliance: No
Severity Score: 22.5			
Codes/Mitigation Info/Possible Solution		Field Measurements/Component Compliance

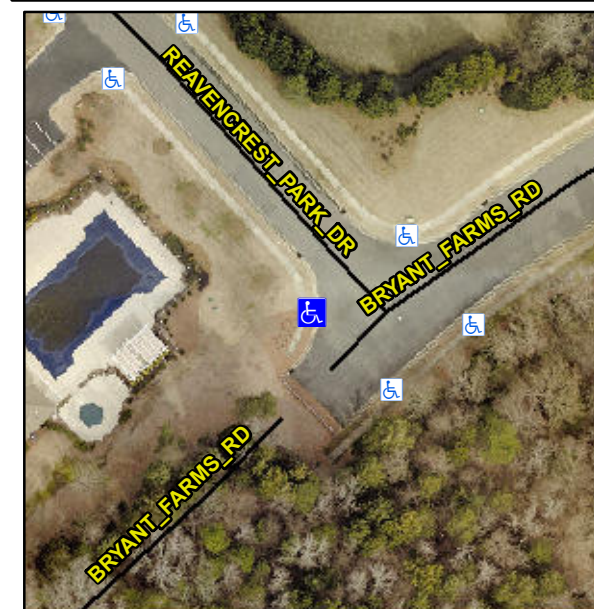
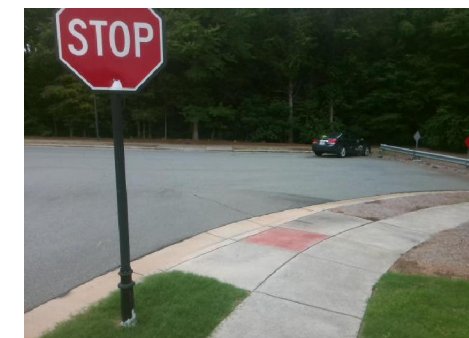
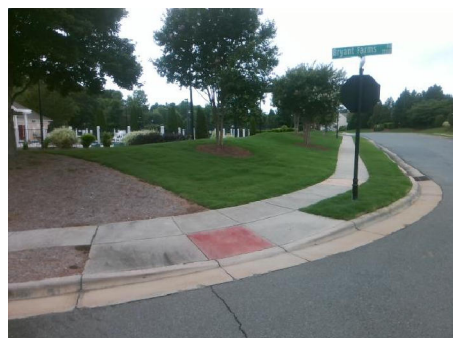
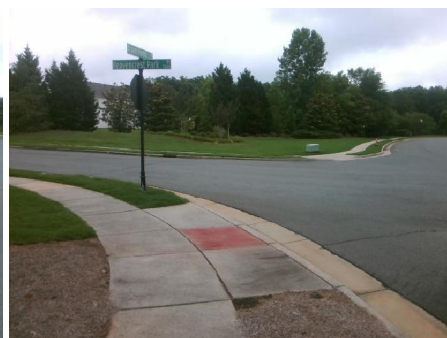
**Not Found, R304.5.1, R304.2.2, R304.5.3**

Compliance	Description	Data	Compliance	Description	Data
N/A	Ramp Length (in)	48.0	No	Ramp Slope (%)	8.5
No	Ramp Width (in)	46.0	No	Ramp XSlope (%)	3.8
N/A	Flare Type LT	N/A	N/A	Flare Type RT	N/A
N/A	Flare Slope LT (%)	N/A	N/A	Flare Slope RT (%)	N/A
N/A	Flare Traversable LT?	N/A	N/A	Flare Traversable RT?	N/A
N/A	Landing Length (in)	N/A	N/A	DWS Provided?	N/A
N/A	Landing Width (in)	N/A	N/A	DWS Contrast?	N/A
N/A	Landing Slope (%)	N/A	N/A	DWS Length (in)	N/A
N/A	Landing X Slope (%)	N/A	N/A	DWS Full Width?	N/A
N/A	Landing Curb? (Y/N)	N/A	N/A	DWS Offset (in)	N/A
N/A	Shared Landing?	N/A			
N/A	Gutter Ponding?	N/A	N/A	Gutter Slope (%)	N/A
N/A	Gutter Lip Ht (in)	N/A	N/A	Gutter X Slope (%)	N/A
N/A	Painted X Walk1?	No	N/A	Painted X Walk2?	No
	X Walk 1 Direction	To SE		X Walk 2 Direction	To NE
N/A	X Walk 1 Width (in)	N/A	N/A	X Walk 2 Width (in)	N/A
	X Walk 1 Slope (%)	1.2		X Walk 2 Slope (%)	4.2
	X Walk 1 X Slope (%)	3.6		X Walk 2 X Slope (%)	1.2

N/A	Ramp inside XWalk1?	N/A	N/A	Ramp inside XWalk2?	N/A
	Road Slope (%)	3.6	N/A	Clear Space?	N/A
	Road X Slope (%)	3.6	N/A	Clear Space to XWalk (in)	N/A
N/A	Any Obstructions?	N/A	N/A	Storm Grate/Utility Hazard?	N/A
	Obstruction Type			Storm Grate/Utility Type	
		N/A			N/A
			Yes	Surface Condition? (G/P)	Good

**Remove & Replace Curb Ramp With Two New Directional Ramps or Equivalent.**
