# Access Compliance Report

## Public Rights-of-Way

### (Curb Ramps)

Intersection ID: 44602	Main Street: JOHNSTON_OEHLER_RD	Cross Street: PROSPERITY_PARK_DR	Location: SE
ADA ID: 6FE34EAAB043	Ramp Type: PerpDiag	Initial Pass/Fail: Fail	Overall Compliance: No
Codes/Mitigation Info/Possible Solution		Field Measurements/Component Compliance	
Severity Score: 58.75

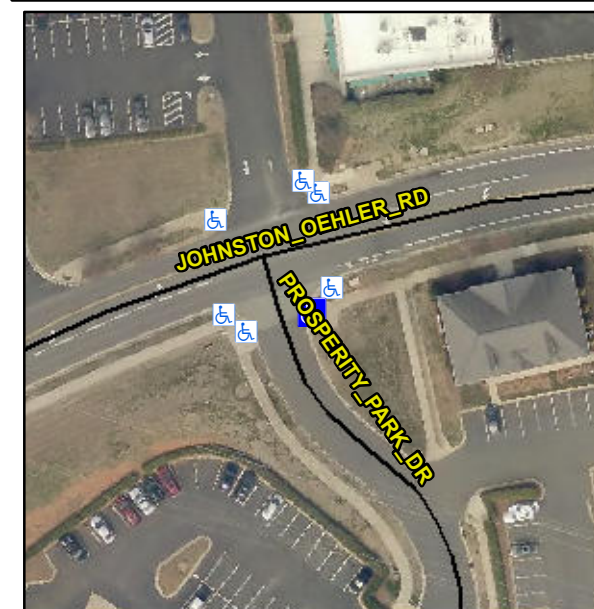
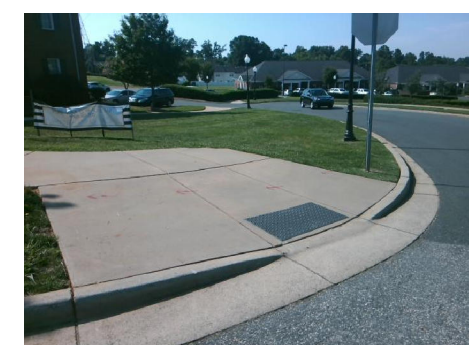
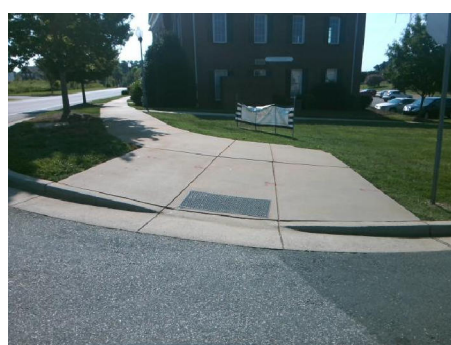
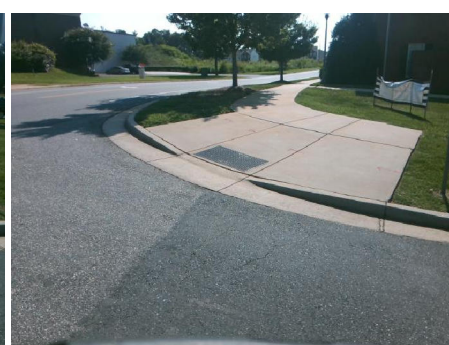
Compliance	Description	Data	Compliance	Description	Data
N/A	Ramp Length (in)	97.0	No	Ramp Slope (%)	16.4
No	Ramp Width (in)	43.5	No	Ramp XSlope (%)	9.9
N/A	Flare Type LT	N/A	N/A	Flare Type RT	N/A
N/A	Flare Slope LT (%)	N/A	N/A	Flare Slope RT (%)	N/A
N/A	Flare Traversable LT?	N/A	N/A	Flare Traversable RT?	N/A
N/A	Landing Length (in)	N/A	N/A	DWS Provided?	N/A
N/A	Landing Width (in)	N/A	N/A	DWS Contrast?	N/A
N/A	Landing Slope (%)	N/A	N/A	DWS Length (in)	N/A
N/A	Landing X Slope (%)	N/A	N/A	DWS Full Width?	N/A
N/A	Landing Curb? (Y/N)	N/A	N/A	DWS Offset (in)	N/A
N/A	Shared Landing?	N/A			
N/A	Gutter Ponding?	N/A	N/A	Gutter Slope (%)	N/A
N/A	Gutter Lip Ht (in)	N/A	N/A	Gutter X Slope (%)	N/A
N/A	Painted X Walk1?	No	N/A	Painted X Walk2?	No
	X Walk 1 Direction	To W		X Walk 2 Direction	To N
N/A	X Walk 1 Width (in)	N/A	N/A	X Walk 2 Width (in)	N/A
	X Walk 1 Slope (%)	4.0		X Walk 2 Slope (%)	7.2
	X Walk 1 X Slope (%)	8.2		X Walk 2 X Slope (%)	1.0

N/A	Ramp inside XWalk1?	N/A	N/A	Ramp inside XWalk2?	N/A
	Road Slope (%)	6.9	N/A	Clear Space?	N/A
	Road X Slope (%)	4.8	N/A	Clear Space to XWalk (in)	N/A
N/A	Any Obstructions?	N/A	N/A	Storm Grate/Utility Hazard?	N/A
	Obstruction Type			Storm Grate/Utility Type	
		N/A			N/A
			Yes	Surface Condition? (G/P)	Good

**Remove & Replace Curb Ramp With Two New Directional Ramps or Equivalent.**

**R304.5.1, R304.2.2, R304.5.3**
