# Access Compliance Report

## Public Rights-of-Way

### (Curb Ramps)

| Intersection ID: 28138 | Main Street: BRYSON_BEND_DR | Cross Street: TAYLORFORD_PL | Location: NE |

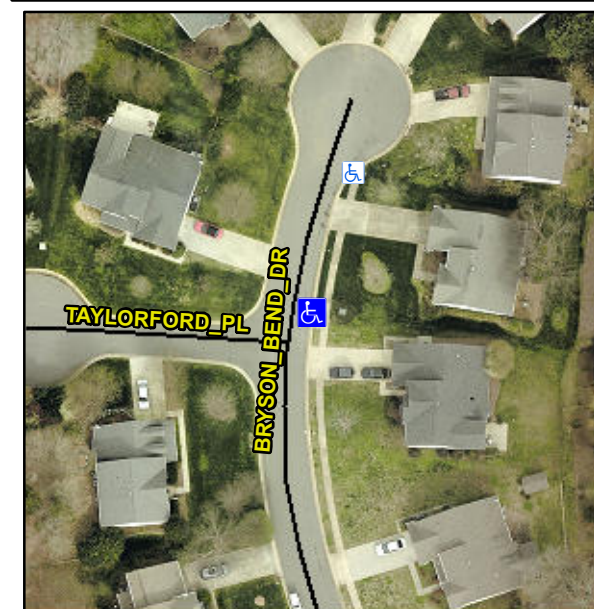
| ADA ID: 6FEA5555381 | Ramp Type: BlendTrans1 | Initial Pass/Fail: Pass | Overall Compliance: No |
| Severity Score: 7.75 | | | |

**Not Found, R304.5.3, R305.2, R302.7.2**

| Compliance | Description | Data | Compliance | Description | Data |
|---|---|---|---|---|---|
| Yes | Ramp Width (in) | 48.0 | No | BlendTrans XSlope (%) | 4.5 |
| N/A | Landing Curb? (Y/N) | No | No | DWS Offset (in) | 3.5 |
| No | Gutter Lip Ht (in) | 0.5 | No | Gutter X Slope (%) | 4.4 |

**Remove & Replace Curb Ramp With Two New Directional Ramps or Equivalent. Remove & Replace Gutter.**

Total Cost: \$ 3950.00
