Access Compliance Report

Public Rights-of-Way

(Curb Ramps)

Intersection ID: 13760	Main Street: EUCLID_AV	Cross Street: TEMPLETON_AV	Location: E
ADA ID: 6FF221305C5C	Ramp Type: Directional1	Initial Pass/Fail: Fail	Overall Compliance: No
Severity Score: 48.75			
Codes/Mitigation Info/Possible Solution		Field Measurements/Component Compliance

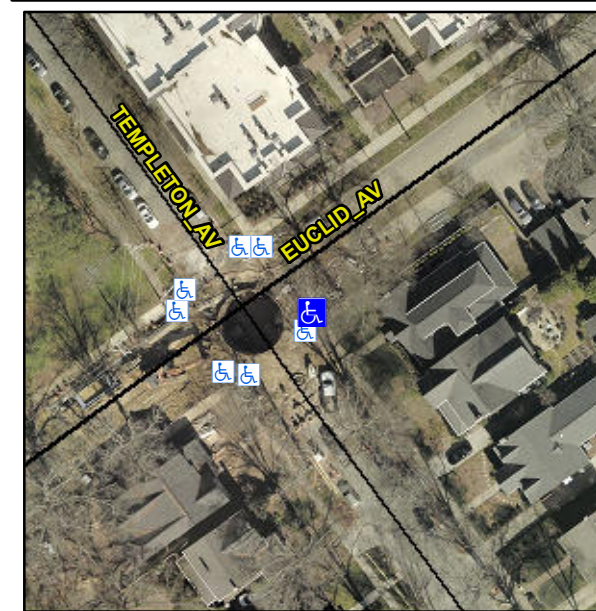
ASP LIP 1.0"

R304.5.1, R304.2.2, R304.5.3

Compliance	Description	Data	Compliance	Description	Data
N/A	Ramp Length (in)	43.0	N/A	Grade Break?	N/A
No	Ramp Width (in)	28.0	N/A	Grade Break Slope (%)	0.0
No	Ramp Slope (%)	10.1	N/A	Grade Break XSlope (%)	0.0
No	Ramp XSlope (%)	3.5			
N/A	Flare Type LT	N/A	N/A	Flare Type RT	N/A
N/A	Flare Slope LT (%)	N/A	N/A	Flare Slope RT (%)	0.0
N/A	Flare Traversable LT?	N/A	N/A	Flare Traversable RT?	N/A
N/A	Landing Length (in)	0.0	N/A	DWS Provided?	N/A
N/A	Landing Width (in)	0.0	N/A	DWS Contrast?	N/A
N/A	Landing Slope (%)	0.0	N/A	DWS Length (in)	N/A
N/A	Landing X Slope (%)	0.0	N/A	DWS Full Width?	N/A
N/A	Landing Curb? (Y/N)	N/A	N/A	DWS Offset LT (in)	N/A
N/A	Shared Landing?	N/A	N/A	DWS Offset RT (in)	N/A
N/A	Gutter Ponding?	0.0	N/A	Gutter Slope (%)	N/A
N/A	Gutter Lip Ht (in)	0.0	N/A	Gutter X Slope (%)	N/A
N/A	Painted X Walk1?	No		Road Slope (%)	5.0
	X Walk 1 Direction	To NW		Road X Slope (%)	3.0
	X Walk 1 Width (in)	N/A		Clear Space?	N/A

X Walk 1 Slope (%)	5.0	N/A	Clear Space to XWalk (in)	N/A
	X Walk 1 X Slope (%)	3.0	N/A	Storm Grate/Utility Hazard?	N/A
N/A	Ramp inside XWalk1?	N/A		Storm Grate/Utility Type	
N/A	Any Obstructions?	N/A			N/A
	Obstruction Type		Yes	Surface Condition? (G/P)	Good
			N/A	Curb Slope (%)	17.4

Possible Solutions:

Remove & Replace Entire Ramp.
