# Access Compliance Report

## Public Rights-of-Way

### (Curb Ramps)

| Intersection ID: 10027514 | Main Street: GRANDIN_RD | Cross Street: N/A | Location: NW |

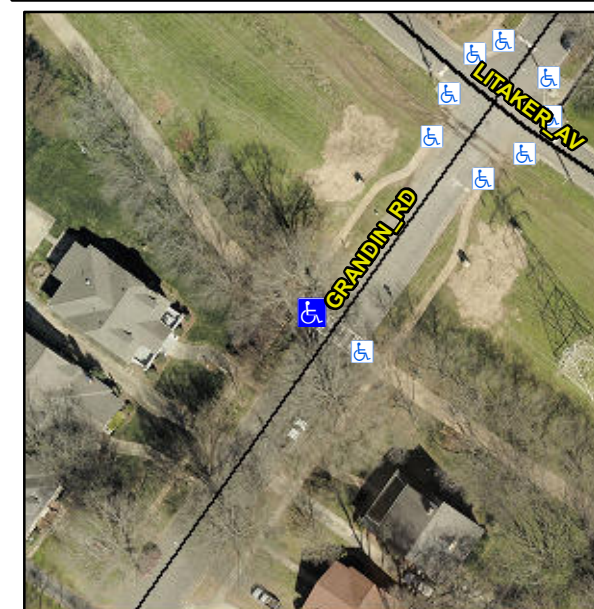
| ADA ID: 700A806DEE5C | Ramp Type: BlendTrans1 | Initial Pass/Fail: Pass | Overall Compliance: No |

| Severity Score: 22.75 | | | |

Surveyor Notes:

**NO CURB**

PROW/ADA:

**R305, R302.7, R302.7.2, R304.5.4,  
R304.5.3**

| Compliance | Description | Data | Compliance | Description | Data |
|---|---|---|---|---|---|
| Yes | Landing Length (in) | 119.0 | No | DWS Provided? | No |
| No | Gutter Ponding? | Yes | No | Gutter Slope (%) | 6.2 |
| No | Gutter Lip Ht (in) | 0.5 | No | Gutter X Slope (%) | 3.7 |

Possible Solutions:

**Install Detectable Warning System.  
Remove & Replace Gutter.**

Total Cost: \$ 985.00
