Access Compliance Report

Public Rights-of-Way

(Curb Ramps)

Intersection ID: 9768	Main Street: EASTWAY_DR	Cross Street: THE_PLAZA	Location: NE
ADA ID: 7010A5E48D76	Ramp Type: PerpDiag	Initial Pass/Fail: Fail	Overall Compliance: No
Severity Score: 46.25			
Codes/Mitigation Info/Possible Solution		Field Measurements/Component Compliance

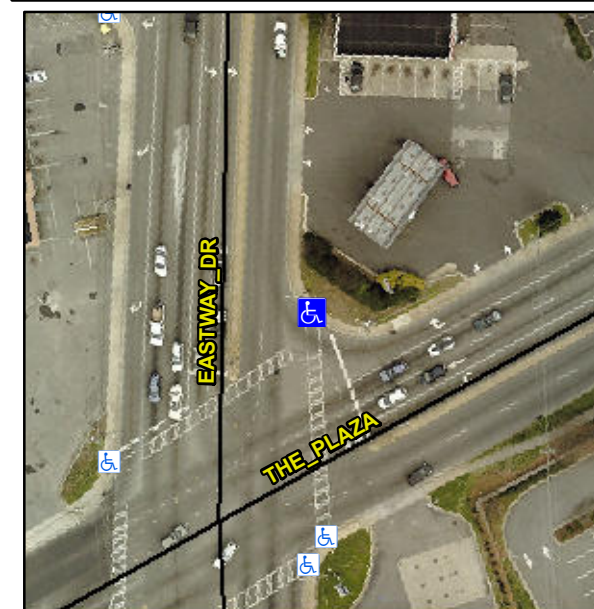
Not Found, R304.5.1, R304.2.2, R304.5.3

Compliance	Description	Data	Compliance	Description	Data
N/A	Ramp Length (in)	58.5	No	Ramp Slope (%)	9.2
No	Ramp Width (in)	37.0	No	Ramp XSlope (%)	10.4
N/A	Flare Type LT	N/A	N/A	Flare Type RT	N/A
N/A	Flare Slope LT (%)	N/A	N/A	Flare Slope RT (%)	N/A
N/A	Flare Traversable LT?	N/A	N/A	Flare Traversable RT?	N/A
N/A	Landing Length (in)	N/A	N/A	DWS Provided?	N/A
N/A	Landing Width (in)	N/A	N/A	DWS Contrast?	N/A
N/A	Landing Slope (%)	N/A	N/A	DWS Length (in)	N/A
N/A	Landing X Slope (%)	N/A	N/A	DWS Full Width?	N/A
N/A	Landing Curb? (Y/N)	N/A	N/A	DWS Offset (in)	N/A
N/A	Shared Landing?	N/A			
N/A	Gutter Ponding?	N/A	N/A	Gutter Slope (%)	N/A
N/A	Gutter Lip Ht (in)	N/A	N/A	Gutter X Slope (%)	N/A
N/A	Painted X Walk1?	Yes	N/A	Painted X Walk2?	Yes
	X Walk 1 Direction	To SW		X Walk 2 Direction	To S
N/A	X Walk 1 Width (in)	73.0	N/A	X Walk 2 Width (in)	77.0
	X Walk 1 Slope (%)	6.5		X Walk 2 Slope (%)	2.0
	X Walk 1 X Slope (%)	2.7		X Walk 2 X Slope (%)	6.5

N/A	Ramp inside XWalk1?	Yes	N/A	Ramp inside XWalk2?	Yes
	Road Slope (%)	6.7	N/A	Clear Space?	N/A
	Road X Slope (%)	2.9	N/A	Clear Space to XWalk (in)	N/A
N/A	Any Obstructions?	N/A	N/A	Storm Grate/Utility Hazard?	N/A
	Obstruction Type			Storm Grate/Utility Type	
		N/A			N/A
		Yes		Surface Condition? (G/P)	Good

Remove & Replace Curb Ramp With Two New Directional Ramps or Equivalent.
