Access Compliance Report

Public Rights-of-Way

(Curb Ramps)

Intersection ID: 14941	Main Street: BENJAMIN_ST	Cross Street: S_TRYON_ST	Location: W
ADA ID: 701EEEB522EE	Ramp Type: PerpDiag	Initial Pass/Fail: Fail	Overall Compliance: No
Severity Score: 13.75			
Codes/Mitigation Info/Possible Solution		Field Measurements/Component Compliance

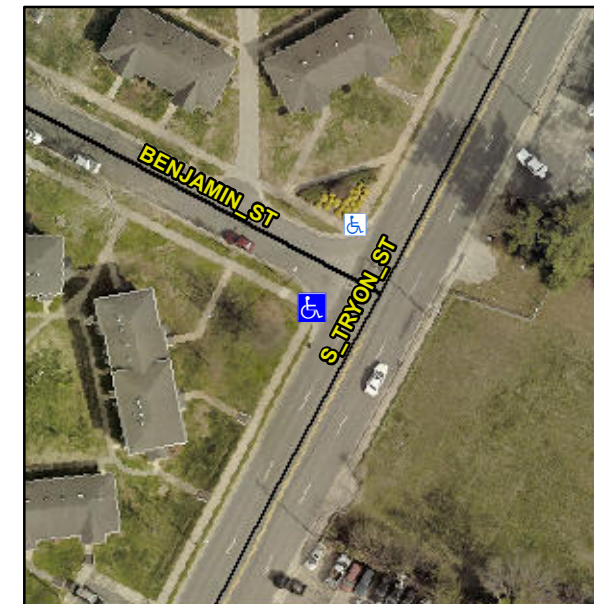
Not Found, R304.2.2, R304.5.3

Compliance	Description	Data	Compliance	Description	Data
N/A	Ramp Length (in)	58.0	No	Ramp Slope (%)	8.7
Yes	Ramp Width (in)	48.0	No	Ramp XSlope (%)	2.1
N/A	Flare Type LT	N/A	N/A	Flare Type RT	N/A
N/A	Flare Slope LT (%)	N/A	N/A	Flare Slope RT (%)	N/A
N/A	Flare Traversable LT?	N/A	N/A	Flare Traversable RT?	N/A
N/A	Landing Length (in)	N/A	N/A	DWS Provided?	N/A
N/A	Landing Width (in)	N/A	N/A	DWS Contrast?	N/A
N/A	Landing Slope (%)	N/A	N/A	DWS Length (in)	N/A
N/A	Landing X Slope (%)	N/A	N/A	DWS Full Width?	N/A
N/A	Landing Curb? (Y/N)	N/A	N/A	DWS Offset (in)	N/A
N/A	Shared Landing?	N/A			
N/A	Gutter Ponding?	N/A	N/A	Gutter Slope (%)	N/A
N/A	Gutter Lip Ht (in)	N/A	N/A	Gutter X Slope (%)	N/A
N/A	Painted X Walk1?	No	N/A	Painted X Walk2?	No
	X Walk 1 Direction	To SE		X Walk 2 Direction	To NE
N/A	X Walk 1 Width (in)	N/A	N/A	X Walk 2 Width (in)	N/A
	X Walk 1 Slope (%)	0.4		X Walk 2 Slope (%)	2.6
	X Walk 1 X Slope (%)	2.4		X Walk 2 X Slope (%)	1.7

N/A	Ramp inside XWalk1?	N/A	N/A	Ramp inside XWalk2?	N/A
	Road Slope (%)	3.9	N/A	Clear Space?	N/A
	Road X Slope (%)	0.6	N/A	Clear Space to XWalk (in)	N/A
N/A	Any Obstructions?	N/A	N/A	Storm Grate/Utility Hazard?	N/A
	Obstruction Type			Storm Grate/Utility Type	
		N/A			N/A
			Yes	Surface Condition? (G/P)	Good

Possible Solutions:

Remove & Replace Curb Ramp With Two New Directional Ramps or Equivalent.
