Access Compliance Report

Public Rights-of-Way

(Curb Ramps)

Intersection ID: 21312	Main Street: E_ARROWOOD_RD	Cross Street: SOUTH_BV	Location: NE
ADA ID: 70217CC48AA6	Ramp Type: Perp	Initial Pass/Fail: Fail	Overall Compliance: No
		Severity Score: 12.5

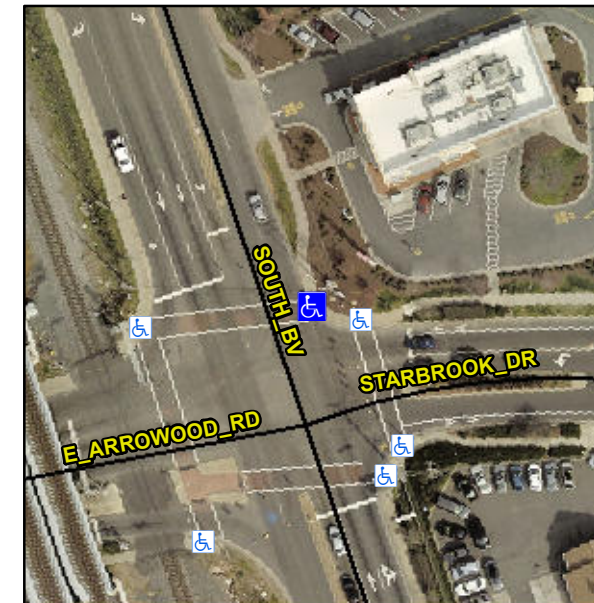
Not Found, R304.2.2

Compliance	Description	Data	Compliance	Description	Data
N/A	Ramp Length (in)	71.0	No	Ramp Slope (%)	9.5
Yes	Ramp Width (in)	48.0	Yes	Ramp XSlope (%)	1.4
N/A	Flare Type LT	N/A	N/A	Flare Type RT	N/A
N/A	Flare Slope LT (%)	N/A	N/A	Flare Slope RT (%)	N/A
N/A	Flare Traversable LT?	N/A	N/A	Flare Traversable RT?	N/A
N/A	Landing Length (in)	N/A	N/A	DWS Provided?	N/A
N/A	Landing Width (in)	N/A	N/A	DWS Contrast?	N/A
N/A	Landing Slope (%)	N/A	N/A	DWS Length (in)	N/A
N/A	Landing X Slope (%)	N/A	N/A	DWS Full Width?	N/A
N/A	Landing Curb? (Y/N)	N/A	N/A	DWS Offset (in)	N/A
N/A	Shared Landing?	N/A			
N/A	Gutter Ponding?	N/A	N/A	Gutter Slope (%)	N/A
N/A	Gutter Lip Ht (in)	N/A	N/A	Gutter X Slope (%)	N/A
N/A	Painted X Walk1?	Yes	N/A	Painted X Walk2?	N/A
	X Walk 1 Direction	To W		X Walk 2 Direction	N/A
N/A	X Walk 1 Width (in)	122.0	N/A	X Walk 2 Width (in)	N/A
	X Walk 1 Slope (%)	7.4		X Walk 2 Slope (%)	N/A
	X Walk 1 X Slope (%)	1.3		X Walk 2 X Slope (%)	N/A

N/A	Ramp inside XWalk1?	Yes	N/A	Ramp inside XWalk2?	N/A
	Road Slope (%)	N/A	N/A	Clear Space?	N/A
	Road X Slope (%)	N/A	N/A	Clear Space to XWalk (in)	N/A
N/A	Any Obstructions?	N/A	N/A	Storm Grate/Utility Hazard?	N/A
	Obstruction Type			Storm Grate/Utility Type	
		N/A			N/A
			Yes	Surface Condition? (G/P)	Good

Possible Solutions:

Remove & Replace Entire Ramp.

Total Cost: \$ 1850.00
