# Access Compliance Report

## Public Rights-of-Way

### (Curb Ramps)

Intersection ID: 45181	Main Street: SOCIETY_ST	Cross Street: WESTON_GLEN_DR	Location: NW
ADA ID: 7026A79B7024	Ramp Type: PerpDiag	Initial Pass/Fail: Fail	Overall Compliance: No
			Severity Score: 21.25

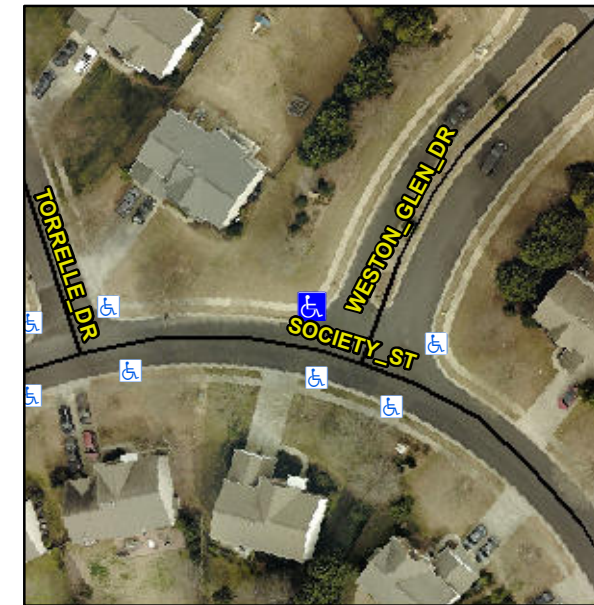
**Not Found, R304.5.1, R304.2.2**

Compliance	Description	Data	Compliance	Description	Data
N/A	Ramp Length (in)	48.5	No	Ramp Slope (%)	9.9
No	Ramp Width (in)	40.0	Yes	Ramp XSlope (%)	1.8
N/A	Flare Type LT	N/A	N/A	Flare Type RT	N/A
N/A	Flare Slope LT (%)	N/A	N/A	Flare Slope RT (%)	N/A
N/A	Flare Traversable LT?	N/A	N/A	Flare Traversable RT?	N/A
N/A	Landing Length (in)	N/A	N/A	DWS Provided?	N/A
N/A	Landing Width (in)	N/A	N/A	DWS Contrast?	N/A
N/A	Landing Slope (%)	N/A	N/A	DWS Length (in)	N/A
N/A	Landing X Slope (%)	N/A	N/A	DWS Full Width?	N/A
N/A	Landing Curb? (Y/N)	N/A	N/A	DWS Offset (in)	N/A
N/A	Shared Landing?	N/A			
N/A	Gutter Ponding?	N/A	N/A	Gutter Slope (%)	N/A
N/A	Gutter Lip Ht (in)	N/A	N/A	Gutter X Slope (%)	N/A
N/A	Painted X Walk1?	No	N/A	Painted X Walk2?	No
	X Walk 1 Direction	To S		X Walk 2 Direction	To SE
N/A	X Walk 1 Width (in)	N/A	N/A	X Walk 2 Width (in)	N/A
	X Walk 1 Slope (%)	2.8		X Walk 2 Slope (%)	4.4
	X Walk 1 X Slope (%)	1.6		X Walk 2 X Slope (%)	0.7

N/A	Ramp inside XWalk1?	N/A	N/A	Ramp inside XWalk2?	N/A
	Road Slope (%)	2.3	N/A	Clear Space?	N/A
	Road X Slope (%)	2.2	N/A	Clear Space to XWalk (in)	N/A
N/A	Any Obstructions?	N/A	N/A	Storm Grate/Utility Hazard?	N/A
	Obstruction Type			Storm Grate/Utility Type	
		N/A			N/A
			Yes	Surface Condition? (G/P)	Good

**Remove & Replace Curb Ramp With Two New Directional Ramps or Equivalent.**
