# Access Compliance Report

## Public Rights-of-Way

### (Curb Ramps)

| Intersection ID: 30450 | Main Street: STEELE_CREEK_RD | Cross Street: SMOKE_MONT_DR | Location: W |

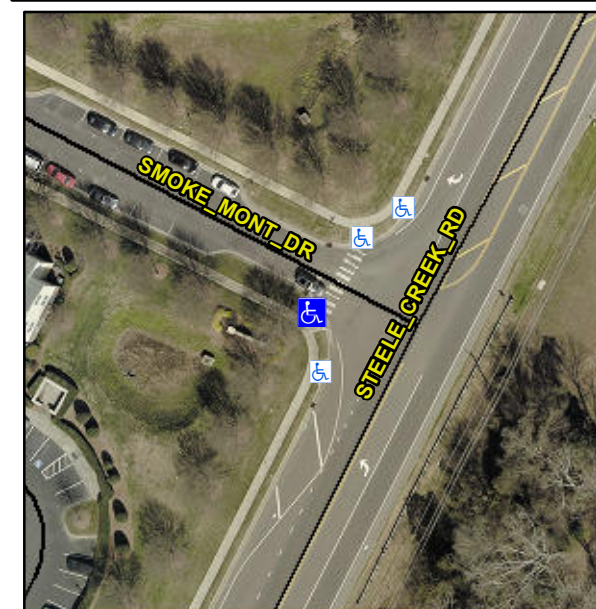
**Not Found, R304.2.1**

| Compliance | Description | Data | Compliance | Description | Data |
|---|---|---|---|---|---|
| No | Landing Length (in) | 46.0 | Yes | DWS Provided? | Yes |
| | | | No | Curb Slope (%) | 20.9 |

**Remove & Replace Curb Ramp With Two New Directional Ramps or Equivalent.**

Total Cost: \$ 3200.00
