# Access Compliance Report

## Public Rights-of-Way

### (Curb Ramps)

| Intersection ID: 10025885 | Main Street: ELIZABETH_AV | Cross Street: N/A | Location: S |

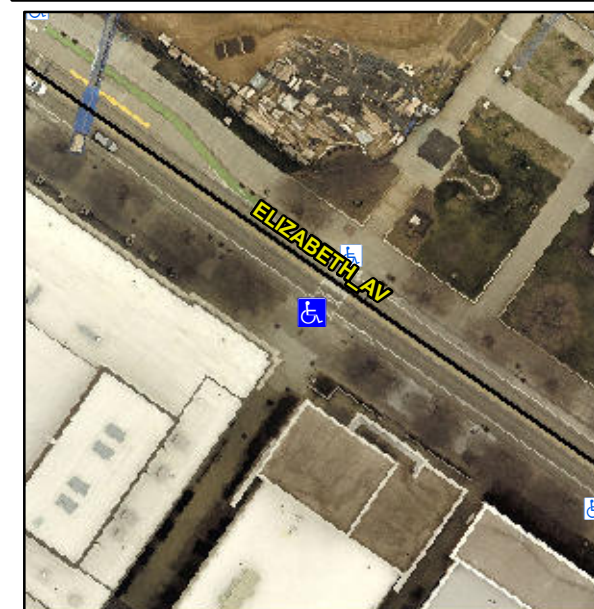
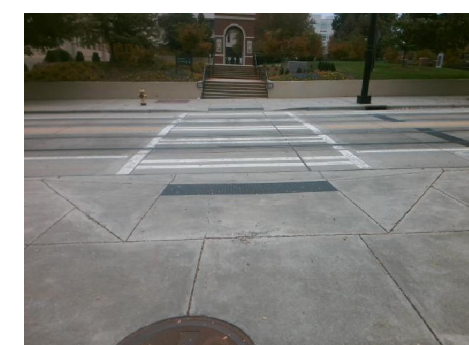
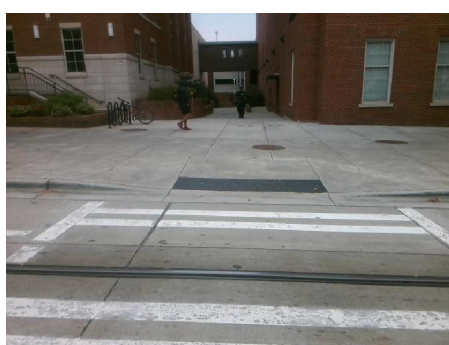
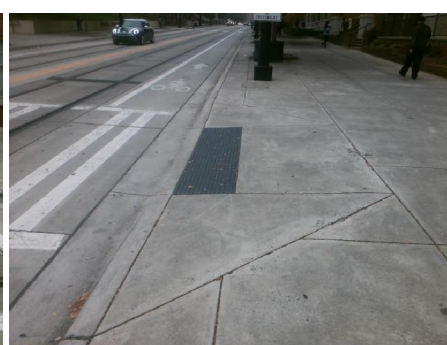
| ADA ID: 702758721307 | Ramp Type: Perp | Initial Pass/Fail: Pass | Overall Compliance: No |

**Not Found, R304.5.3, R304.2.3,  
R304.5.4**

| Compliance | Description | Data | Compliance | Description | Data |
|---|---|---|---|---|---|
| Yes | Ramp Width (in) | 96.5 | No | Ramp XSlope (%) | 4.3 |
| Yes | Gutter Ponding? | No | No | Gutter Slope (%) | 7.9 |
| Yes | Gutter Lip Ht (in) | 0.0 | No | Gutter X Slope (%) | 4.1 |

**Remove & Replace Entire Ramp.  
Remove & Replace Gutter.**
