# Access Compliance Report

## Public Rights-of-Way

### (Curb Ramps)

Intersection ID: 30285	Main Street: DERRYFIELD_DR	Cross Street: HAMPTON_WAY_DR	Location: NW
ADA ID: 702B87B771A2	Ramp Type: BlendTrans1	Initial Pass/Fail: Fail	Overall Compliance: No
Severity Score: 10			
Codes/Mitigation Info/Possible Solution		Field Measurements/Component Compliance

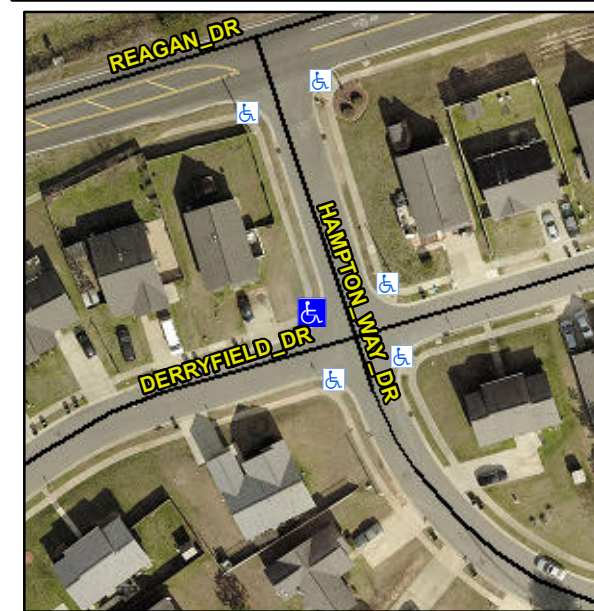
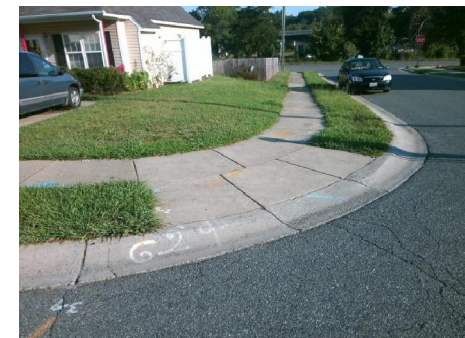
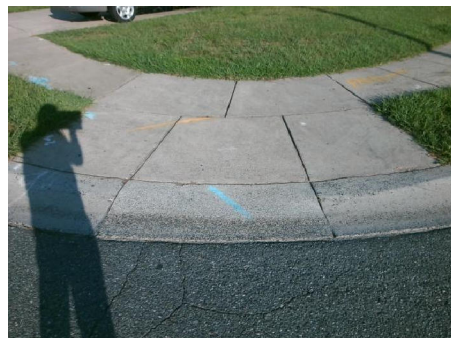
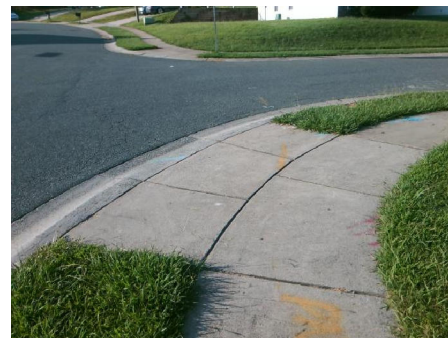
**Not Found, R304.5.1, R304.5.3**

Compliance	Description	Data	Compliance	Description	Data
N/A	Ramp Length (in)	47.5	Yes	BlendTrans Slope (%)	1.9
No	Ramp Width (in)	42.5	No	BlendTrans XSlope (%)	2.9
N/A	Flare Type LT	N/A	N/A	Flare Type RT	N/A
N/A	Flare Slope LT (%)	N/A	N/A	Flare Slope RT (%)	N/A
N/A	Flare Traversable LT?	N/A	N/A	Flare Traversable RT?	N/A
N/A	Landing Length (in)	N/A	N/A	DWS Provided?	N/A
N/A	Landing Width (in)	N/A	N/A	DWS Contrast?	N/A
N/A	Landing Slope (%)	N/A	N/A	DWS Length (in)	N/A
N/A	Landing X Slope (%)	N/A	N/A	DWS Full Width?	N/A
N/A	Landing Curb? (Y/N)	N/A	N/A	DWS Offset (in)	N/A
N/A	Shared Landing?	N/A			
N/A	Gutter Ponding?	N/A	N/A	Gutter Slope (%)	N/A
N/A	Gutter Lip Ht (in)	N/A	N/A	Gutter X Slope (%)	N/A
N/A	Painted X Walk1?	No	N/A	Painted X Walk2?	No
	X Walk 1 Direction	To SE		X Walk 2 Direction	To NE
	X Walk 1 Width (in)	N/A		X Walk 2 Width (in)	N/A
	X Walk 1 Slope (%)	5.9		X Walk 2 Slope (%)	5.2
	X Walk 1 X Slope (%)	1.5		X Walk 2 X Slope (%)	4.0

N/A	Ramp inside XWalk1?	N/A	N/A	Ramp inside XWalk2?	N/A
	Road Slope (%)	1.9		Clear Space?	N/A
	Road X Slope (%)	6.7	N/A	Clear Space to XWalk (in)	N/A
N/A	Any Obstructions?	N/A	N/A	Storm Grate/Utility Hazard?	N/A
	Obstruction Type			Storm Grate/Utility Type	
		N/A			N/A
			Yes	Surface Condition? (G/P)	Good
			No	Curb Slope (%)	21.8

**Remove & Replace Curb Ramp With Two New Directional Ramps or Equivalent.**

Total Cost: \$ 3200.00
