# Access Compliance Report

## Public Rights-of-Way

### (Curb Ramps)

Intersection ID: 3194	Main Street: HIGHCROFT_LN	Cross Street: OLD_BRIDGE_LN	Location: SW
ADA ID: 704FA6999FAE	Ramp Type: Perp	Initial Pass/Fail: Fail	Overall Compliance: No
Severity Score: 12.5			
Codes/Mitigation Info/Possible Solution		Field Measurements/Component Compliance

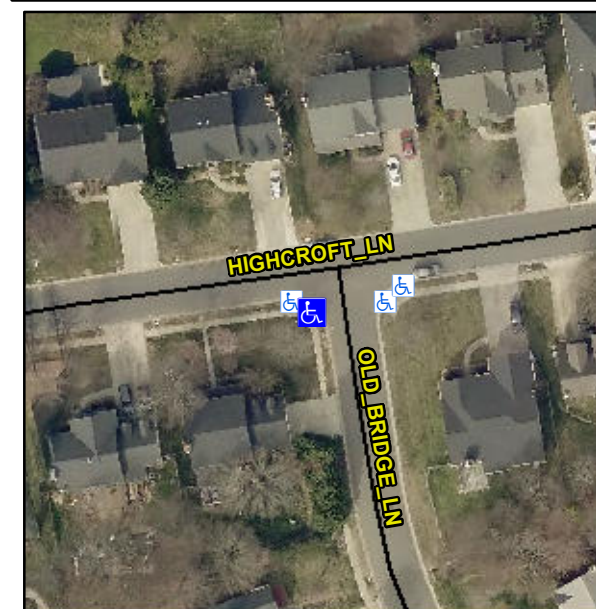
**Not Found, R304.5.3**

Compliance	Description	Data	Compliance	Description	Data
N/A	Ramp Length (in)	48.0	Yes	Ramp Slope (%)	5.0
Yes	Ramp Width (in)	48.0	No	Ramp XSlope (%)	6.8
N/A	Flare Type LT	N/A	N/A	Flare Type RT	N/A
N/A	Flare Slope LT (%)	N/A	N/A	Flare Slope RT (%)	N/A
N/A	Flare Traversable LT?	N/A	N/A	Flare Traversable RT?	N/A
N/A	Landing Length (in)	N/A	N/A	DWS Provided?	N/A
N/A	Landing Width (in)	N/A	N/A	DWS Contrast?	N/A
N/A	Landing Slope (%)	N/A	N/A	DWS Length (in)	N/A
N/A	Landing X Slope (%)	N/A	N/A	DWS Full Width?	N/A
N/A	Landing Curb? (Y/N)	N/A	N/A	DWS Offset (in)	N/A
N/A	Shared Landing?	N/A			
N/A	Gutter Ponding?	N/A	N/A	Gutter Slope (%)	N/A
N/A	Gutter Lip Ht (in)	N/A	N/A	Gutter X Slope (%)	N/A
N/A	Painted X Walk1?	No	N/A	Painted X Walk2?	N/A
	X Walk 1 Direction	To E		X Walk 2 Direction	N/A
N/A	X Walk 1 Width (in)	N/A	N/A	X Walk 2 Width (in)	N/A
	X Walk 1 Slope (%)	0.2		X Walk 2 Slope (%)	N/A
	X Walk 1 X Slope (%)	4.0		X Walk 2 X Slope (%)	N/A

N/A	Ramp inside XWalk1?	N/A	N/A	Ramp inside XWalk2?	N/A
	Road Slope (%)	N/A	N/A	Clear Space?	N/A
	Road X Slope (%)	N/A	N/A	Clear Space to XWalk (in)	N/A
N/A	Any Obstructions?	N/A	N/A	Storm Grate/Utility Hazard?	N/A
	Obstruction Type			Storm Grate/Utility Type	
		N/A			N/A
		Yes		Surface Condition? (G/P)	Good

**Remove & Replace Entire Ramp.**

Total Cost: \$ 1850.00
