# Access Compliance Report

## Public Rights-of-Way

| Intersection ID: 22295 | Main Street: HUCKLEBERRY_RD | Cross Street: KRONOS_PL | Location: | N |
| ADA ID: 70561EE08DE2 | Ramp Type: BlendTrans1 | Initial Pass/Fail: Pass | Overall Compliance: No | Severity Score: 10.25 |

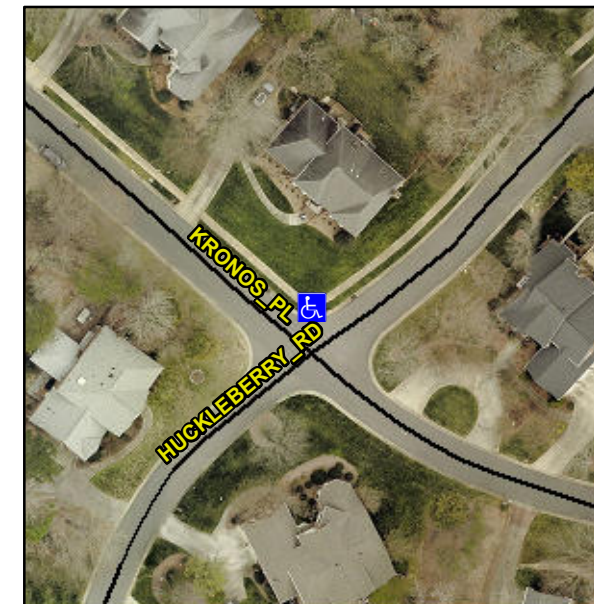
**Not Found, R304.5.3, R305**

| Compliance | Description | Data | Compliance | Description | Data |
|---|---|---|---|---|---|
| Yes | Ramp Width (in) | 81.0 | No | BlendTrans XSlope (%) | 3.4 |
| Yes | Landing Length (in) | 50.0 | No | DWS Provided? | No |
| No | Landing X Slope (%) | 2.1 | N/A | DWS Full Width? | No |

**Remove & Replace Curb Ramp With Two New Directional Ramps or Equivalent.**

Total Cost: \$ 3200.00

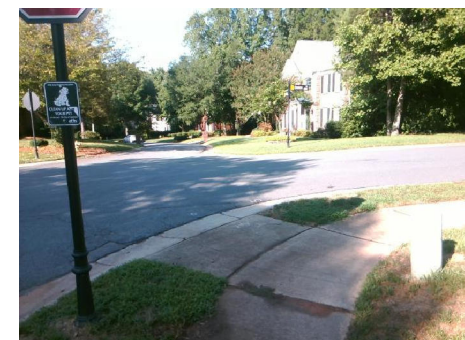
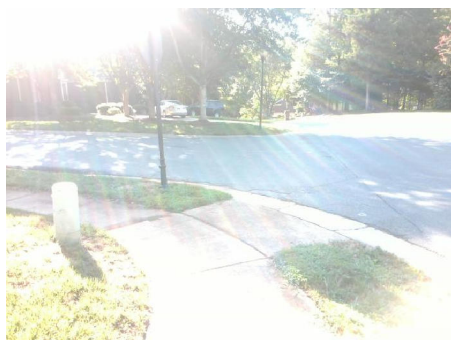
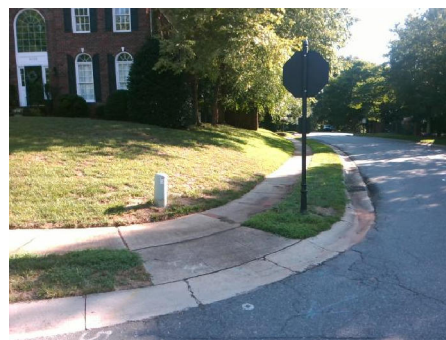
Street 1 Name KRONOS PL  
 Stop Condition-Street 1 None  
 Street 2 Name HUCKLEBERRY RD  
 Stop Condition-Street 2 StopSign
