# Access Compliance Report

## Public Rights-of-Way

### (Curb Ramps)

Intersection ID: 32118	Main Street: COLE_MILL_RD	Cross Street: DUNDALK_RD	Location: W
ADA ID: 705880D66D02	Ramp Type: PerpDiag	Initial Pass/Fail: Fail	Overall Compliance: No
Severity Score: 10			
Codes/Mitigation Info/Possible Solution		Field Measurements/Component Compliance

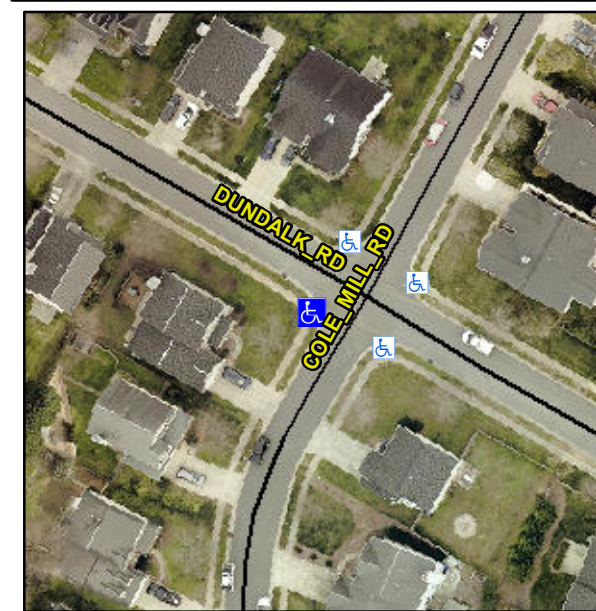
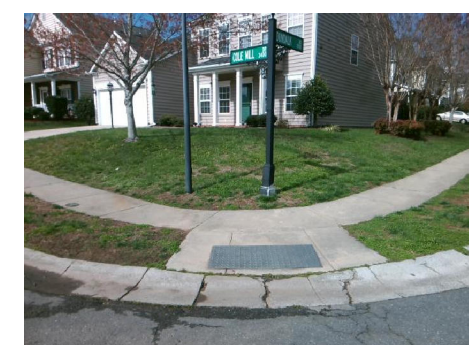
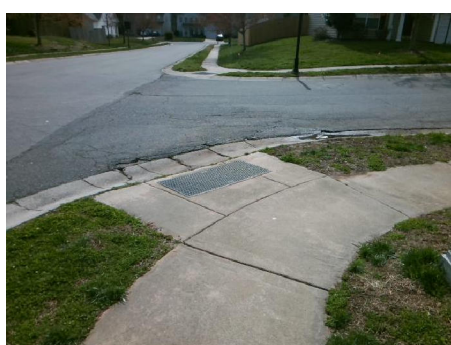
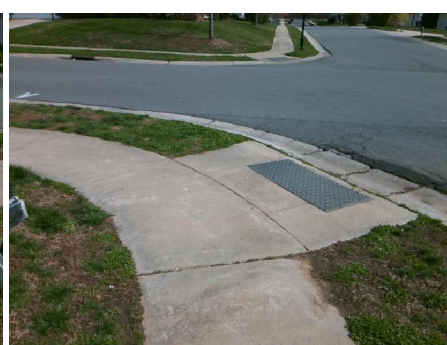
**Not Found, R304.5.1, R304.5.3**

Compliance	Description	Data	Compliance	Description	Data
N/A	Ramp Length (in)	49.0	Yes	Ramp Slope (%)	8.0
No	Ramp Width (in)	39.0	No	Ramp XSlope (%)	2.2
N/A	Flare Type LT	N/A	N/A	Flare Type RT	N/A
N/A	Flare Slope LT (%)	N/A	N/A	Flare Slope RT (%)	N/A
N/A	Flare Traversable LT?	N/A	N/A	Flare Traversable RT?	N/A
N/A	Landing Length (in)	N/A	N/A	DWS Provided?	N/A
N/A	Landing Width (in)	N/A	N/A	DWS Contrast?	N/A
N/A	Landing Slope (%)	N/A	N/A	DWS Length (in)	N/A
N/A	Landing X Slope (%)	N/A	N/A	DWS Full Width?	N/A
N/A	Landing Curb? (Y/N)	N/A	N/A	DWS Offset (in)	N/A
N/A	Shared Landing?	N/A			
N/A	Gutter Ponding?	N/A	N/A	Gutter Slope (%)	N/A
N/A	Gutter Lip Ht (in)	N/A	N/A	Gutter X Slope (%)	N/A
N/A	Painted X Walk1?	No	N/A	Painted X Walk2?	No
	X Walk 1 Direction	To SE		X Walk 2 Direction	To NE
N/A	X Walk 1 Width (in)	N/A	N/A	X Walk 2 Width (in)	N/A
	X Walk 1 Slope (%)	2.6		X Walk 2 Slope (%)	3.2
	X Walk 1 X Slope (%)	1.2		X Walk 2 X Slope (%)	2.5

N/A	Ramp inside XWalk1?	N/A	N/A	Ramp inside XWalk2?	N/A
	Road Slope (%)	1.6	N/A	Clear Space?	N/A
	Road X Slope (%)	0.4	N/A	Clear Space to XWalk (in)	N/A
N/A	Any Obstructions?	N/A	N/A	Storm Grate/Utility Hazard?	N/A
	Obstruction Type			Storm Grate/Utility Type	
		N/A			N/A
			Yes	Surface Condition? (G/P)	Good

**Remove & Replace Curb Ramp With Two New Directional Ramps or Equivalent.**
