Access Compliance Report Public Rights-of-Way (Curb Ramps)

| Intersection ID: 27113 | 3 Main Street: ALEXANDER_VALLEY_DR | | | | treet: | PROVIDENCE RD | Location: | SE | | |
| ADA ID: 705A667EBBAB | | | | | Initial Pass/Fail: Fail Overall Compliance: No | | | | | 22.5 |

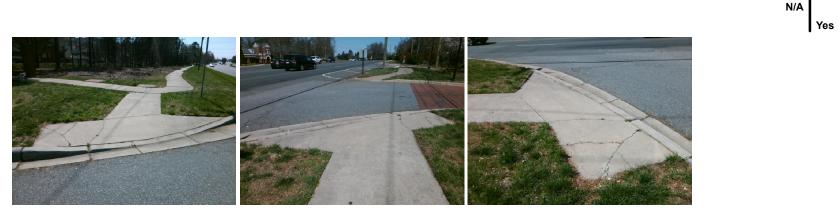
| Intersection ID: 27113 | 3 Main Street: ALEXANDER_VALLEY_DR | | | | treet: | PROVIDENCE RD | Location: | SE | | |
|---|--|---|---|---|--|---|---|---|---|---|
| | | Remove & Repla | ce Entire Ramp. | | N/A | Ramp Length (in) | 47.5 | No | Ramp Slope (%) | 10.0 |
| 3 4 | | | | | No | Ramp Width (in) | 47.0 | Yes | Ramp XSlope (%) | 2.6 |
| | | Not Found, R304 | I.5.1, R304.2.2 | | N/A | Gutter Lip Ht (in) | N/A | N/A | Gutter X Slope (%) | N/A |

| Intersection ID: 27113 | 3 Main Street: ALEXANDER_VALLEY_DR | | | | treet: | PROVIDENCE RD | Location: | SE | | |
|---|--|---|---|---|--|---|---|---|---|---|
| 1 1 1 Part Street | 3 - F | Possible Solutions: | | Compliance Description | | | Data Compliance Description | | | Data |
| | | Total Cost: | \$ 1 | 850.00 | | Obstruction Type | | | Storm Grate/Utility Type | |
