Access Compliance Report

Public Rights-of-Way

(Curb Ramps)

Intersection ID: 11695	Main Street: PARKWOOD_AV	Cross Street: THE_PLAZA	Location: SW
ADA ID: 705C1B71BD8A	Ramp Type: Para	Initial Pass/Fail: Fail	Overall Compliance: No
Severity Score: 13.75			
Codes/Mitigation Info/Possible Solution		Field Measurements/Component Compliance

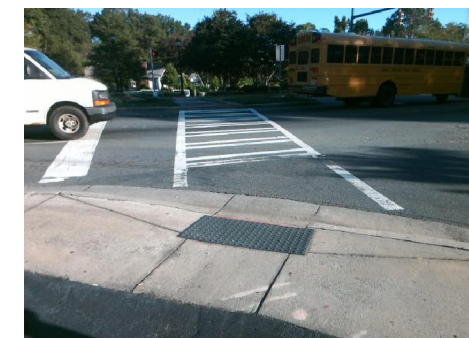
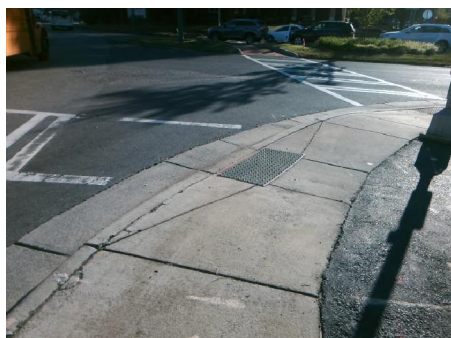
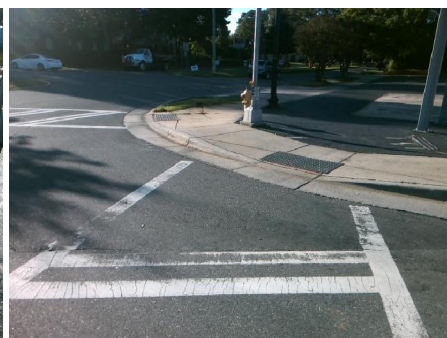
LT RP < 5%

R304.5.3, R304.3.2

Compliance	Description	Data	Compliance	Description	Data
N/A	Ramp Length LT (in)	58.0	N/A	Ramp Length RT (in)	61.5
Yes	Ramp Width LT (in)	60.5	Yes	Ramp Width RT (in)	59.5
Yes	Ramp Slope LT (%)	3.1	No	Ramp Slope RT (%)	10.2
No	Ramp XSlope LT (%)	2.8	Yes	Ramp XSlope RT (%)	1.6
N/A	Landing Length (in)	N/A	N/A	DWS Provided?	N/A
N/A	Landing Width (in)	N/A	N/A	DWS Contrast?	N/A
N/A	Landing Slope (%)	N/A	N/A	DWS Length (in)	N/A
N/A	Landing X Slope (%)	N/A	N/A	DWS Full Width?	N/A
N/A	Landing Curb? (Y/N)	N/A	N/A	DWS Offset (in)	N/A
N/A	Shared Landing?	N/A			
N/A	Gutter Ponding?	N/A	N/A	Gutter Slope (%)	N/A
N/A	Gutter Lip Ht (in)	N/A	N/A	Gutter X Slope (%)	N/A
N/A	Painted X Walk1?	Yes	N/A	Painted X Walk2?	N/A
	X Walk 1 Direction	To N		X Walk 2 Direction	N/A
N/A	X Walk 1 Width (in)	93.0	N/A	X Walk 2 Width (in)	N/A
	X Walk 1 Slope (%)	2.4		X Walk 2 Slope (%)	N/A
	X Walk 1 X Slope (%)	0.9		X Walk 2 X Slope (%)	N/A
N/A	Ramp inside XWalk1?	Yes	N/A	Ramp inside XWalk2?	N/A

Road Slope (%)	N/A	N/A	Clear Space?	N/A
	Road X Slope (%)	N/A	N/A	Clear Space to XWalk (in)	N/A
N/A	Any Obstructions?	N/A	N/A	Storm Grate/Utility Hazard?	N/A
	Obstruction Type			Storm Grate/Utility Type	
		N/A			N/A
			Yes	Surface Condition? (G/P)	Good
			N/A	Curb Slope (%)	6.2

Remove & Replace Entire Ramp.

Total Cost: \$ 1600.00
