Access Compliance Report Public Rights-of-Way (Curb Ramps)

Intersection ID: N/AMain Street:ENGLISH_SADDLE_LNCross Street:SANDY_PORTER_RDLocation:NEADA ID: 705C90F0DF8CRamp Type:PerpInitial Pass/Fail:FailOverall Compliance:NoSeverity Score:12.5

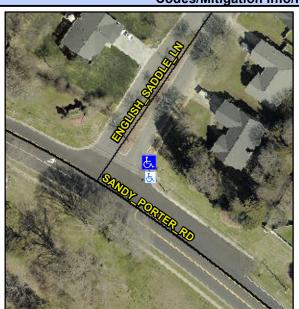
Not Found, R304.2.2

Compliance Description Data Compliance Description No Ramp Slope (%) N/A Ramp Length (in) 93.0 Ramp XSlope (%) Yes Ramp Width (in) 48.0 Yes N/A N/A Flare Type LT N/A Flare Type RT N/A N/A N/A Flare Slope RT (%) Flare Slope LT (%) N/A Flare Traversable LT? N/A N/A Flare Traversable RT? N/A N/A N/A DWS Provided? Landing Length (in) N/A Landing Width (in) N/A N/A **DWS Contrast?** N/A N/A N/A Landing Slope (%) DWS Length (in) N/A Landing X Slope (%) N/A N/A DWS Full Width? N/A Landing Curb? (Y/N) N/A N/A DWS Offset (in) N/A N/A Shared Landing? N/A **Gutter Ponding?** N/A N/A Gutter Slope (%) Gutter Lip Ht (in) N/A N/A Gutter X Slope (%) Painted X Walk1? No N/A Painted X Walk2? X Walk 1 Direction To NW X Walk 2 Direction N/A X Walk 1 Width (in) X Walk 2 Width (in) X Walk 1 Slope (%) 0.1 X Walk 2 Slope (%) X Walk 1 X Slope (%) 0.0 X Walk 2 X Slope (%) N/A N/A Ramp inside XWalk2? Ramp inside XWalk1? Road Slope (%) N/A N/A Clear Space? Road X Slope (%) N/A N/A Clear Space to XWalk (in) N/A Any Obstructions? N/A Storm Grate/Utility Hazard? **Obstruction Type** Storm Grate/Utility Type

Remove & Replace Entire Ramp.
