# Access Compliance Report

## Public Rights-of-Way

### (Curb Ramps)

Intersection ID: 2684	Main Street: CARDINAL_POINT_RD	Cross Street: SUMMERGOLD_WY	Location: SW
ADA ID: 705D0C8E9EFD	Ramp Type: Perp	Initial Pass/Fail: Pass	Overall Compliance: No
Severity Score: 0			
Codes/Mitigation Info/Possible Solution		Field Measurements/Component Compliance

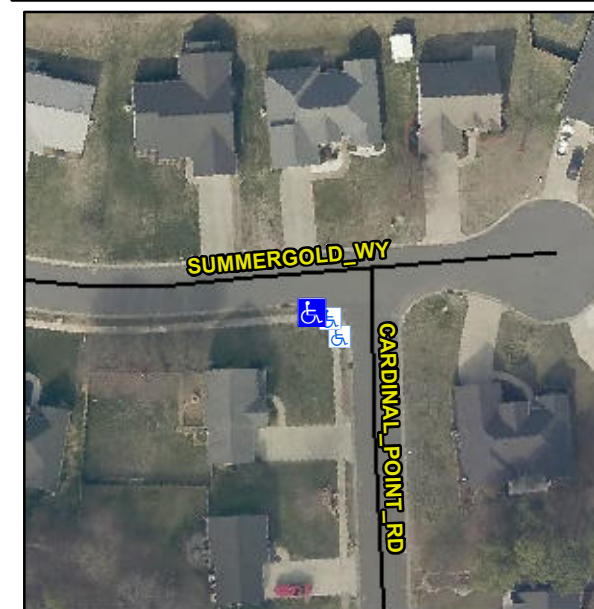
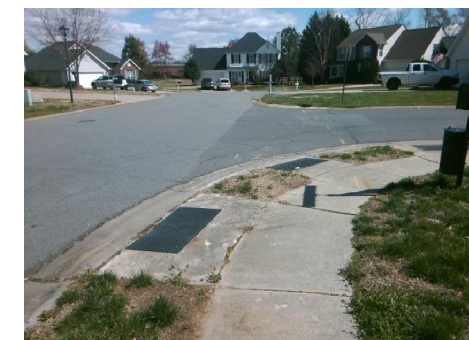
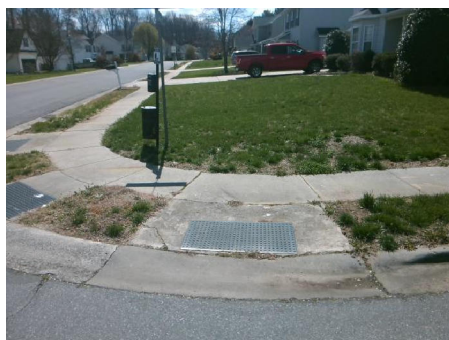
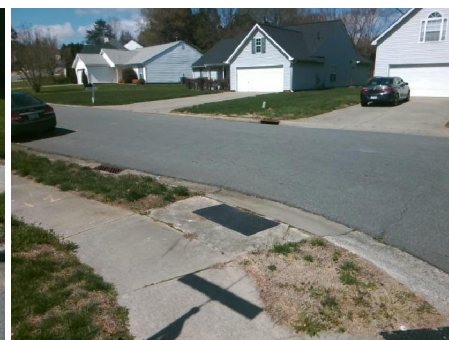
**Not Found, R305.2**

Compliance	Description	Data	Compliance	Description	Data
N/A	Ramp Length (in)	48.0	Yes	Ramp Slope (%)	5.5
Yes	Ramp Width (in)	48.0	Yes	Ramp XSlope (%)	1.5
N/A	Flare Type LT	Sloped	N/A	Flare Type RT	N/A
N/A	Flare Slope LT (%)	5.2	Yes	Flare Slope RT (%)	4.2
N/A	Flare Traversable LT?	Yes	N/A	Flare Traversable RT?	Yes
Yes	Landing Length (in)	48.0	Yes	DWS Provided?	Yes
Yes	Landing Width (in)	48.0	Yes	DWS Contrast?	Yes
Yes	Landing Slope (%)	1.6	Yes	DWS Length (in)	25.5
Yes	Landing X Slope (%)	1.1	Yes	DWS Full Width?	Yes
N/A	Landing Curb? (Y/N)	No	No	DWS Offset (in)	3.5
N/A	Shared Landing?	No			
Yes	Gutter Ponding?	No	Yes	Gutter Slope (%)	0.4
Yes	Gutter Lip Ht (in)	0.0	Yes	Gutter X Slope (%)	1.4
N/A	Painted X Walk1?	No	N/A	Painted X Walk2?	N/A
	X Walk 1 Direction	To N		X Walk 2 Direction	N/A
N/A	X Walk 1 Width (in)	N/A	N/A	X Walk 2 Width (in)	N/A
	X Walk 1 Slope (%)	4.5		X Walk 2 Slope (%)	N/A
	X Walk 1 X Slope (%)	0.2		X Walk 2 X Slope (%)	N/A

N/A	Ramp inside XWalk1?	N/A	N/A	Ramp inside XWalk2?	N/A
	Road Slope (%)	N/A	N/A	Clear Space?	Yes
	Road X Slope (%)	N/A	N/A	Clear Space to XWalk (in)	N/A
Yes	Any Obstructions?	No	Yes	Storm Grate/Utility Hazard?	No
	Obstruction Type			Storm Grate/Utility Type	
			N/A		N/A
			Yes	Surface Condition? (G/P)	Good

**Remove & Replace Entire Ramp.**
