# Access Compliance Report

## Public Rights-of-Way

### (Curb Ramps)

Intersection ID: 6839	Main Street: BELMEADE_DR	Cross Street: BELMEADE_GREEN_DR	Location: S
ADA ID: 705FD38B3EAE	Ramp Type: Perp	Initial Pass/Fail: Fail	Overall Compliance: No
Severity Score: 22.5			
Codes/Mitigation Info/Possible Solution		Field Measurements/Component Compliance

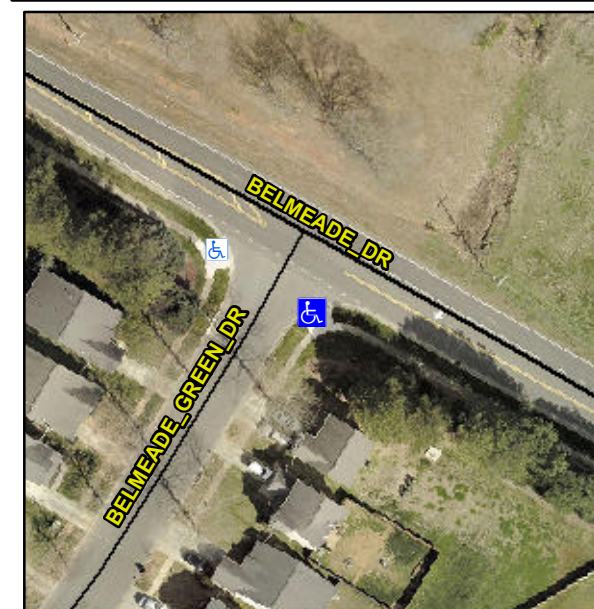
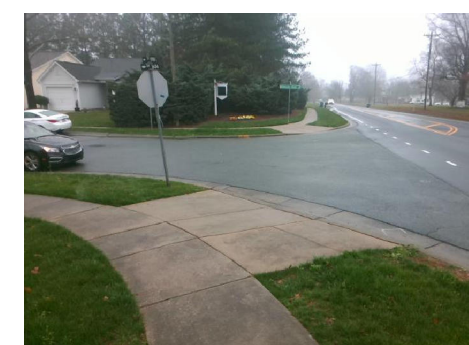
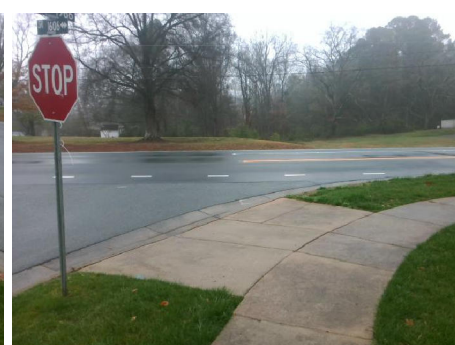
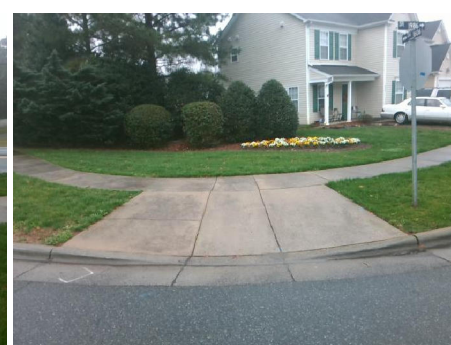
Compliance	Description	Data	Compliance	Description	Data
N/A	Ramp Length (in)	95.0	No	Ramp Slope (%)	11.0
No	Ramp Width (in)	37.0	No	Ramp XSlope (%)	4.3
N/A	Flare Type LT	N/A	N/A	Flare Type RT	N/A
N/A	Flare Slope LT (%)	N/A	N/A	Flare Slope RT (%)	N/A
N/A	Flare Traversable LT?	N/A	N/A	Flare Traversable RT?	N/A
N/A	Landing Length (in)	N/A	N/A	DWS Provided?	N/A
N/A	Landing Width (in)	N/A	N/A	DWS Contrast?	N/A
N/A	Landing Slope (%)	N/A	N/A	DWS Length (in)	N/A
N/A	Landing X Slope (%)	N/A	N/A	DWS Full Width?	N/A
N/A	Landing Curb? (Y/N)	N/A	N/A	DWS Offset (in)	N/A
N/A	Shared Landing?	N/A			
N/A	Gutter Ponding?	N/A	N/A	Gutter Slope (%)	N/A
N/A	Gutter Lip Ht (in)	N/A	N/A	Gutter X Slope (%)	N/A
N/A	Painted X Walk1?	No	N/A	Painted X Walk2?	N/A
	X Walk 1 Direction	To NW		X Walk 2 Direction	N/A
N/A	X Walk 1 Width (in)	N/A	N/A	X Walk 2 Width (in)	N/A
	X Walk 1 Slope (%)	1.9		X Walk 2 Slope (%)	N/A
	X Walk 1 X Slope (%)	3.8		X Walk 2 X Slope (%)	N/A

N/A	Ramp inside XWalk1?	N/A	N/A	Ramp inside XWalk2?	N/A
	Road Slope (%)	N/A	N/A	Clear Space?	N/A
	Road X Slope (%)	N/A	N/A	Clear Space to XWalk (in)	N/A
N/A	Any Obstructions?	N/A	N/A	Storm Grate/Utility Hazard?	N/A
	Obstruction Type			Storm Grate/Utility Type	
		N/A			N/A
			Yes	Surface Condition? (G/P)	Good

**Remove & Replace Entire Ramp.**

**R304.5.1, R304.2.2, R304.5.3**
