# Access Compliance Report

## Public Rights-of-Way

### (Curb Ramps)

Intersection ID: 10952	Main Street: N_GRAHAM_ST	Cross Street: STATESVILLE_AV	Location: S
ADA ID: 7076C34055DB	Ramp Type: Perp	Initial Pass/Fail: Fail	Overall Compliance: No
Severity Score: 8.75			
Codes/Mitigation Info/Possible Solution		Field Measurements/Component Compliance

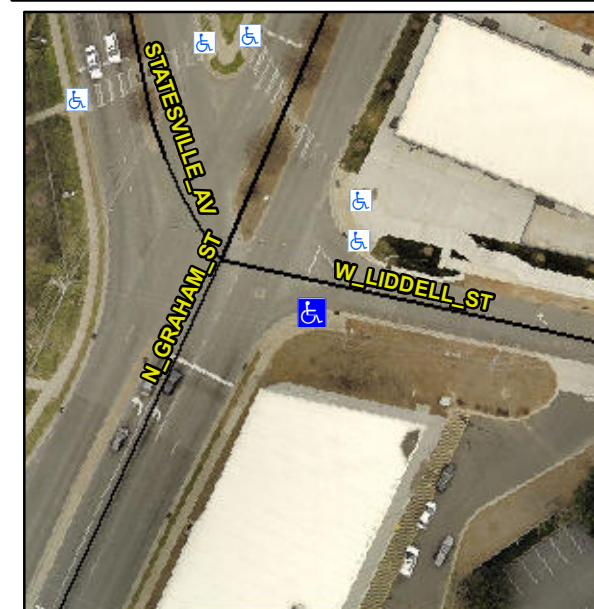
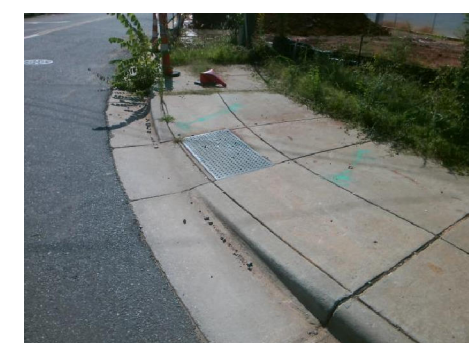
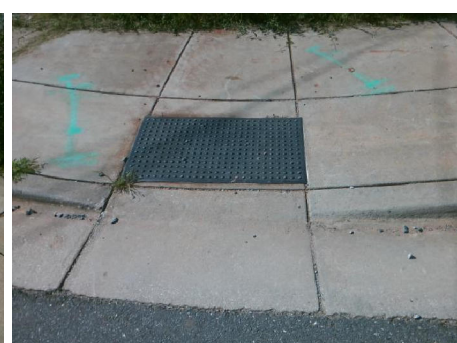
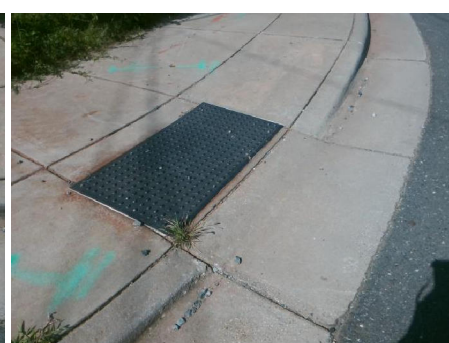
**Not Found, R304.5.1**

Compliance	Description	Data	Compliance	Description	Data
N/A	Ramp Length (in)	35.5	Yes	Ramp Slope (%)	8.0
No	Ramp Width (in)	42.0	Yes	Ramp XSlope (%)	1.4
N/A	Flare Type LT	N/A	N/A	Flare Type RT	N/A
N/A	Flare Slope LT (%)	N/A	N/A	Flare Slope RT (%)	N/A
N/A	Flare Traversable LT?	N/A	N/A	Flare Traversable RT?	N/A
N/A	Landing Length (in)	N/A	N/A	DWS Provided?	N/A
N/A	Landing Width (in)	N/A	N/A	DWS Contrast?	N/A
N/A	Landing Slope (%)	N/A	N/A	DWS Length (in)	N/A
N/A	Landing X Slope (%)	N/A	N/A	DWS Full Width?	N/A
N/A	Landing Curb? (Y/N)	N/A	N/A	DWS Offset (in)	N/A
N/A	Shared Landing?	N/A			
N/A	Gutter Ponding?	N/A	N/A	Gutter Slope (%)	N/A
N/A	Gutter Lip Ht (in)	N/A	N/A	Gutter X Slope (%)	N/A
N/A	Painted X Walk1?	No	N/A	Painted X Walk2?	N/A
	X Walk 1 Direction	To NE		X Walk 2 Direction	N/A
N/A	X Walk 1 Width (in)	N/A	N/A	X Walk 2 Width (in)	N/A
	X Walk 1 Slope (%)	2.4		X Walk 2 Slope (%)	N/A
	X Walk 1 X Slope (%)	1.1		X Walk 2 X Slope (%)	N/A

N/A	Ramp inside XWalk1?	N/A	N/A	Ramp inside XWalk2?	N/A
	Road Slope (%)	N/A	N/A	Clear Space?	N/A
	Road X Slope (%)	N/A	N/A	Clear Space to XWalk (in)	N/A
N/A	Any Obstructions?	N/A	N/A	Storm Grate/Utility Hazard?	N/A
	Obstruction Type			Storm Grate/Utility Type	
		N/A			N/A
			Yes	Surface Condition? (G/P)	Good

**Remove & Replace Entire Ramp.**

Total Cost: \$ 1850.00
