## Access Compliance Report Public Rights-of-Way (Curb Ramps)

Intersection ID: 11483 Main Street: E\_17TH\_ST Cross Street: N\_CALDWELL\_ST Location: N

ADA ID: 70779F61E7AF Ramp Type: PerpDiag Initial Pass/Fail: Fail Overall Compliance: No Severity Score: 26.25

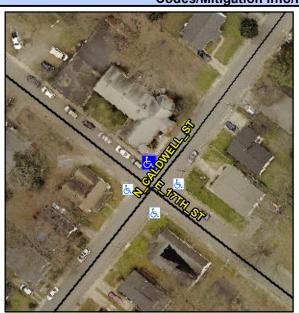
Compliance Description Data Compliance Description Data No N/A Ramp Length (in) 66.0 Ramp Slope (%) 17.2 No Ramp XSlope (%) Yes Ramp Width (in) 65.0 3.0 N/A N/A Flare Type LT N/A Flare Type RT N/A N/A N/A Flare Slope RT (%) N/A Flare Slope LT (%) N/A N/A Flare Traversable LT? N/A N/A Flare Traversable RT? N/A N/A N/A N/A DWS Provided? N/A Landing Length (in) N/A Landing Width (in) N/A N/A **DWS Contrast?** N/A N/A N/A Landing Slope (%) N/A DWS Length (in) N/A N/A Landing X Slope (%) N/A N/A DWS Full Width? N/A N/A Landing Curb? (Y/N) N/A N/A DWS Offset (in) N/A N/A N/A Shared Landing? N/A Gutter Ponding? N/A N/A Gutter Slope (%) N/A N/A Gutter Lip Ht (in) 1.0 N/A Gutter X Slope (%) N/A N/A Painted X Walk1? No N/A Painted X Walk2? No X Walk 1 Direction To SW X Walk 2 Direction To SE N/A N/A X Walk 1 Width (in) X Walk 2 Width (in) N/A X Walk 1 Slope (%) 2.5 X Walk 2 Slope (%) 4.9 X Walk 2 X Slope (%) X Walk 1 X Slope (%) 2.0 0.9 N/A N/A N/A Ramp inside XWalk2? Ramp inside XWalk1? N/A Road Slope (%) 1.4 N/A Clear Space? N/A N/A Road X Slope (%) 4.5 Clear Space to XWalk (in) N/A

Remove & Replace Curb Ramp With Two New Directional Ramps or Equivalent.

R304.2.2, R304.5.3
