# Access Compliance Report

## Public Rights-of-Way

### (Curb Ramps)

| Intersection ID: 10622 | Main Street: MULBERRY_CHURCH_RD | Cross Street: QUEEN_CITY_DR | Location: SW |

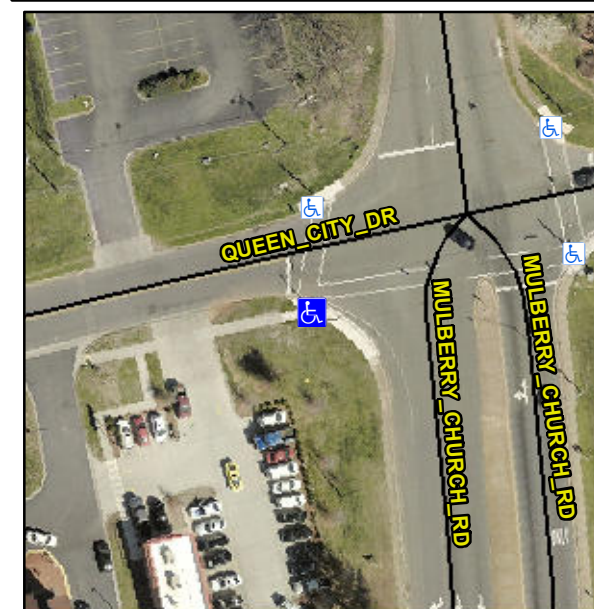
| ADA ID: 707A7E2FDAE9 | Ramp Type: PerpDiag | Initial Pass/Fail: Fail | Overall Compliance: No |
| Severity Score: 48.75 | | | |

**Not Found, R304.5.1, R304.2.2, R304.5.3**

| Compliance | Description | Data | Compliance | Description | Data |
|---|---|---|---|---|---|
| N/A | Ramp Length (in) | 62.0 | No | Ramp Slope (%) | 8.8 |
| No | Ramp Width (in) | 30.0 | No | Ramp XSlope (%) | 2.6 |

**Remove & Replace Curb Ramp With Two New Directional Ramps or Equivalent.**

Total Cost: \$ 3200.00
