Access Compliance Report

Public Rights-of-Way

(Curb Ramps)

Intersection ID: 43653	Main Street: HUNTINGTON_MEADOW_LN	Cross Street: TAGGERT_TRAIL_DR	Location: NE
ADA ID: 70810EF52A96	Ramp Type: Perp	Initial Pass/Fail: Fail	Overall Compliance: No
		Severity Score: 12.5

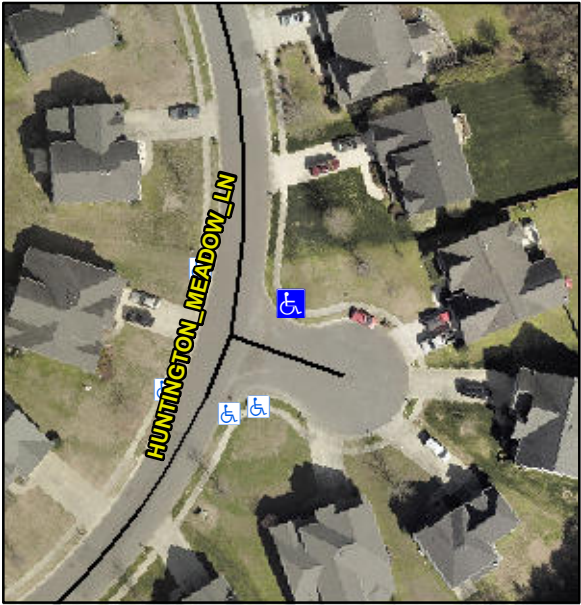
Possible Solutions:		Compliance	Description	Data
	Remove & Replace Entire Ramp.		No	Ramp Length (in)	42.0
			Yes	Ramp Width (in)	49.0
			N/A	Flare Type LT	N/A
			N/A	Flare Slope LT (%)	N/A
			N/A	Flare Traversable LT?	N/A
			N/A	Landing Length (in)	N/A
			N/A	Landing Width (in)	N/A
			N/A	Landing Slope (%)	N/A
			N/A	Landing X Slope (%)	N/A
<p>Surveyor Notes:</p> <p>N/A</p> <p>PROW/ADA:</p> <p>Not Found, R304.2.2</p>			N/A	Flare Type RT	N/A
			N/A	Flare Slope RT (%)	N/A
			N/A	Flare Traversable RT?	N/A
			N/A	DWS Provided?	N/A
			N/A	DWS Contrast?	N/A
			N/A	DWS Length (in)	N/A
			N/A	DWS Full Width?	N/A
			N/A	DWS Offset (in)	N/A
			N/A	Shared Landing?	N/A
			N/A	Gutter Ponding?	N/A
			N/A	Gutter Lip Ht (in)	N/A
			N/A	Painted X Walk1?	No
				X Walk 1 Direction	To S
			N/A	X Walk 1 Width (in)	N/A
				X Walk 1 Slope (%)	1.9
				X Walk 1 X Slope (%)	1.2

N/A	Ramp inside XWalk1?	N/A
			N/A	Road Slope (%)	N/A
			N/A	Road X Slope (%)	N/A
			N/A	Any Obstructions?	N/A
				Obstruction Type	
			N/A		
			N/A		
			N/A		
			N/A		
			N/A		
			N/A		
			N/A		
			N/A		
			N/A		
			Yes	Surface Condition? (G/P)	Good
