# Access Compliance Report

## Public Rights-of-Way

### (Curb Ramps)

| Intersection ID: 16483 | Main Street: QUEENS_RD | Cross Street: RADCLIFFE_AV | Location: S |

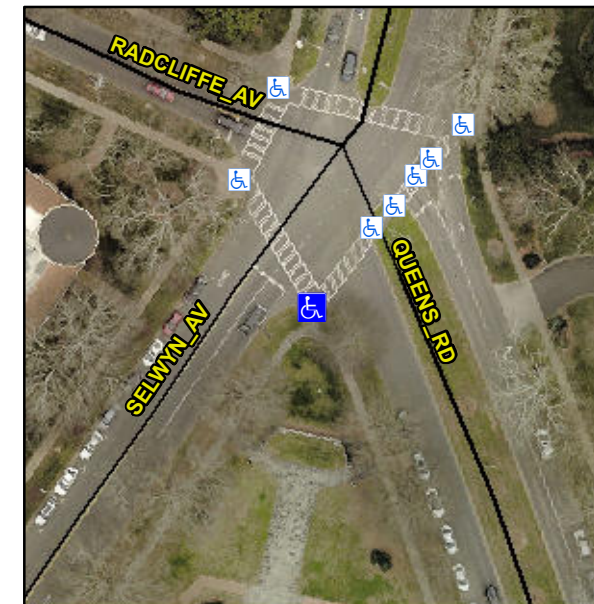
| ADA ID: 7082D4DE4867 | Ramp Type: PerpDiag | Initial Pass/Fail: Fail | Overall Compliance: No |

| Compliance | Description | Data | Compliance | Description | Data |
|---|---|---|---|---|---|
| N/A | Ramp Length (in) | 146.0 | No | Ramp Slope (%) | 13.7 |

**Remove & Replace Curb Ramp With Two New Directional Ramps or Equivalent.**

**R304.2.2**

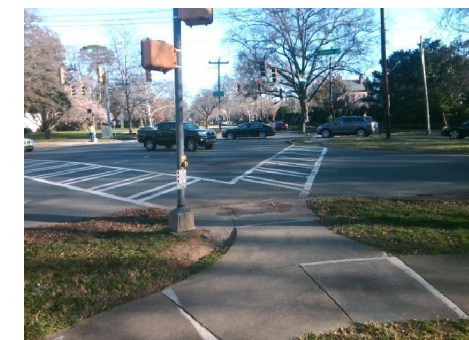
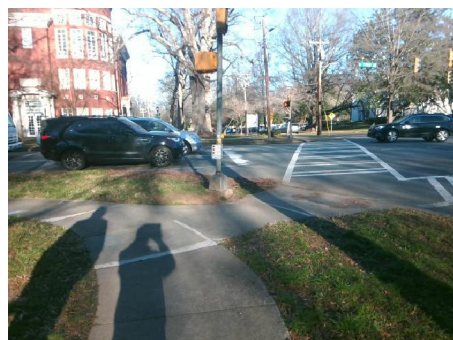
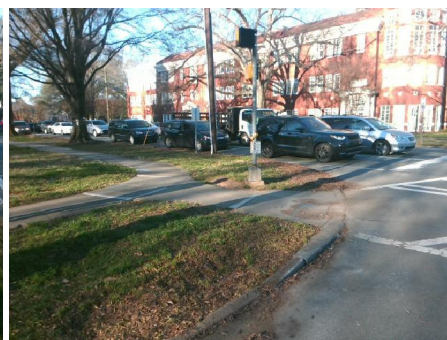
| Compliance | Description | Data | Compliance | Description | Data |
|---|---|---|---|---|---|
| Yes | Ramp Width (in) | 48.0 | Yes | Ramp XSlope (%) | 0.6 |
