| Intersection ID: 25032 | Main Street: CARMEL_RD | Cross Street: SHADOWLAKE_DR | Location: | W |
| ADA ID: 709351BEC4A5 | Ramp Type: PerpDiag | Initial Pass/Fail: Fail | Overall Compliance: No | Severity Score: 10 |

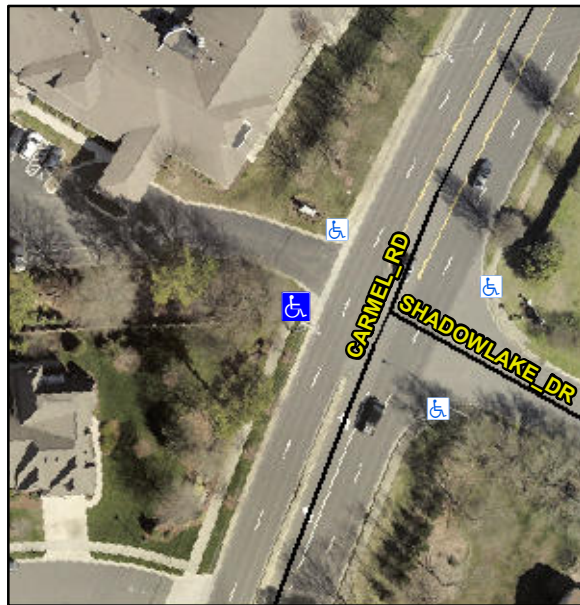
R304.5.1, R304.5.3

| Compliance | Description | Data | Compliance | Description | Data |
|---|---|---|---|---|---|
| N/A | Ramp Length (in) | 60.0 | Yes | Ramp Slope (%) | 5.5 |
| No | Ramp Width (in) | 46.0 | No | Ramp XSlope (%) | 3.0 |

Remove & Replace Curb Ramp With Two New Directional Ramps or Equivalent.
