Access Compliance Report

Public Rights-of-Way

(Curb Ramps)

Intersection ID: 30456	Main Street: STEELE_MEADOW_RD	Cross Street: WALLAND_LN	Location: NW
ADA ID: 709794DD5725	Ramp Type: PerpDiag	Initial Pass/Fail: Fail	Overall Compliance: No
Severity Score: 12.5			
Codes/Mitigation Info/Possible Solution		Field Measurements/Component Compliance

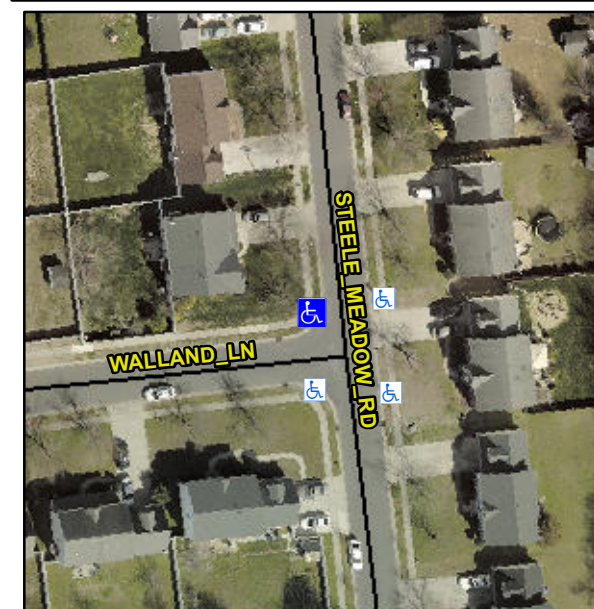
Compliance	Description	Data	Compliance	Description	Data
N/A	Ramp Length (in)	49.0	No	Ramp Slope (%)	9.3
Yes	Ramp Width (in)	48.0	Yes	Ramp XSlope (%)	1.8
N/A	Flare Type LT	N/A	N/A	Flare Type RT	N/A
N/A	Flare Slope LT (%)	N/A	N/A	Flare Slope RT (%)	N/A
N/A	Flare Traversable LT?	N/A	N/A	Flare Traversable RT?	N/A
N/A	Landing Length (in)	N/A	N/A	DWS Provided?	N/A
N/A	Landing Width (in)	N/A	N/A	DWS Contrast?	N/A
N/A	Landing Slope (%)	N/A	N/A	DWS Length (in)	N/A
N/A	Landing X Slope (%)	N/A	N/A	DWS Full Width?	N/A
N/A	Landing Curb? (Y/N)	N/A	N/A	DWS Offset (in)	N/A
N/A	Shared Landing?	N/A			
N/A	Gutter Ponding?	N/A	N/A	Gutter Slope (%)	N/A
N/A	Gutter Lip Ht (in)	N/A	N/A	Gutter X Slope (%)	N/A
N/A	Painted X Walk1?	No	N/A	Painted X Walk2?	No
	X Walk 1 Direction	To S		X Walk 2 Direction	To E
N/A	X Walk 1 Width (in)	N/A	N/A	X Walk 2 Width (in)	N/A
	X Walk 1 Slope (%)	1.4		X Walk 2 Slope (%)	2.9
	X Walk 1 X Slope (%)	2.4		X Walk 2 X Slope (%)	1.5

N/A	Ramp inside XWalk1?	N/A	N/A	Ramp inside XWalk2?	N/A
	Road Slope (%)	2.7	N/A	Clear Space?	N/A
	Road X Slope (%)	0.0	N/A	Clear Space to XWalk (in)	N/A
N/A	Any Obstructions?	N/A	N/A	Storm Grate/Utility Hazard?	N/A
	Obstruction Type			Storm Grate/Utility Type	
		N/A			N/A
			Yes	Surface Condition? (G/P)	Good

Possible Solutions:

Remove & Replace Curb Ramp With Two New Directional Ramps or Equivalent.
