# Access Compliance Report

## Public Rights-of-Way

### (Curb Ramps)

| Intersection ID: 16483 | Main Street: QUEENS_RD | Cross Street: RADCLIFFE_AV | Location: E |

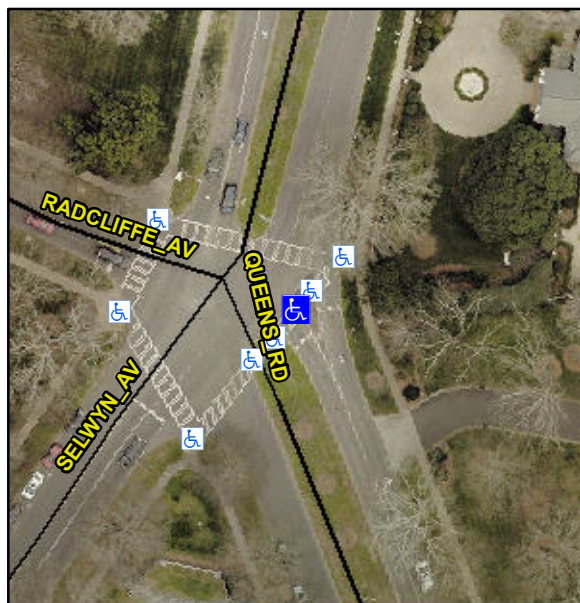
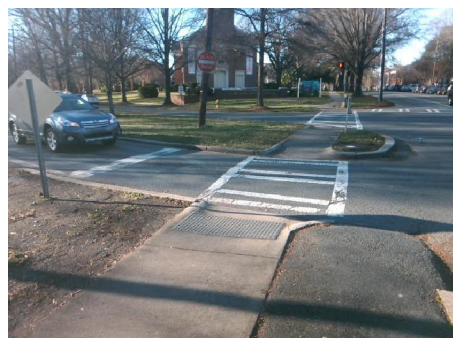
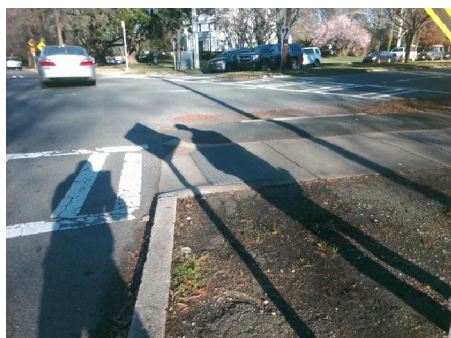
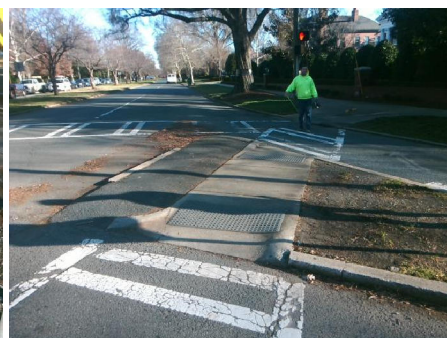
| ADA ID: 7098106745CA | Ramp Type: MedianPerp | Initial Pass/Fail: Fail | Overall Compliance: No |

**Not Found, R304.5.1, R304.5.3**

| Compliance | Description | Data | Compliance | Description | Data |
|---|---|---|---|---|---|
| N/A | Ramp Length (in) | 56.0 | Yes | Ramp Slope (%) | 5.2 |
| No | Ramp Width (in) | 46.0 | No | Ramp XSlope (%) | 7.8 |

**Remove & Replace Entire Ramp.**
