## **Access Compliance Report Public Rights-of-Way** (Curb Ramps)

Intersection ID: 30178 Main Street: DELANDER\_LN Cross Street: HIDDEN\_CREEK\_DR Location: ADA ID: 70A16B6E792E Ramp Type: Perp Initial Pass/Fail: Fail **Overall Compliance: No Severity Score:** 10

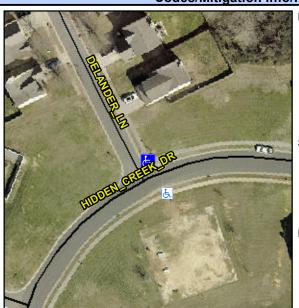
Field Measurements/Component Compliance								
Compliance Description		Data	Comp	liance	Description	Data		
N/A	Ramp Length (in)	49.0	Yes	Ram	Slope (%)	5.3		
No	Ramp Width (in)	47.5	No	Ram	XSlope (%)	2.7		
N/A	Flare Type LT	N/A	N/A	I/A Flare Type RT		N/A		
N/A	Flare Slope LT (%)	N/A	N/A	Flare Slope RT (%)		N/A		
N/A	Flare Traversable LT?	N/A	N/A	Flare Traversable RT?		N/A		
N/A	Landing Length (in)	N/A	N/A	DWS	Provided?	N/A		
N/A	Landing Width (in)	N/A	N/A	DWS	Contrast?	N/A		
N/A	Landing Slope (%)	N/A	N/A	DWS	Length (in)	N/A		
N/A	Landing X Slope (%)	N/A	N/A	DWS	Full Width?	N/A		
N/A	Landing Curb? (Y/N)	N/A	N/A	DWS	Offset (in)	N/A		
N/A	Shared Landing?	N/A						
N/A	Gutter Ponding?	N/A	N/A	Gutte	er Slope (%)	N/A		
N/A	Gutter Lip Ht (in)	0.5	N/A	Gutte	er X Slope (%)	N/A		
N/A	Painted X Walk1?	No	N/A	Paint	ed X Walk2?	N/A		
	X Walk 1 Direction	To S		X Wa	lk 2 Direction	N/A		
N/A	X Walk 1 Width (in)	N/A	N/A	X Wa	lk 2 Width (in)	N/A

X Walk 1 Slope (%)	2.7		X Wa	lk 2 Slope (%)	N/A		
	X Walk 1 X Slope (%)	0.4		X Wa	lk 2 X Slope (%)	N/A		
N/A	Ramp inside XWalk1?	N/A	N/A	Ram	o inside XWalk2?	N/A		
	Road Slope (%)	N/A	N/A	Clear	Space?	N/A		
	Road X Slope (%)	N/A	N/A	Clear	Space to XWalk (in)	N/A		
N/A	Any Obstructions?	N/A	N/A	Storn	n Grate/Utility Hazard?	N/A		
	Obstruction Type			Storn	n Grate/Utility Type			
		N/A				N/A		
			Yes	Surfa	ce Condition? (G/P)	Good

Possible Solutions: Remove & Replace Entire Ramp. Surveyor Notes: N/A PROW/ADA: Not Found, R304.5.1, R304.5.3

Total Cost: 1850.00
