Access Compliance Report

Public Rights-of-Way

(Curb Ramps)

Intersection ID: 47283	Main Street: REIDHAVEN_ST	Cross Street: NETTLETON_CT	Location: SE
ADA ID: 70A31DB23857	Ramp Type: BlendTrans1	Initial Pass/Fail: Fail	Overall Compliance: No
		Severity Score: 10

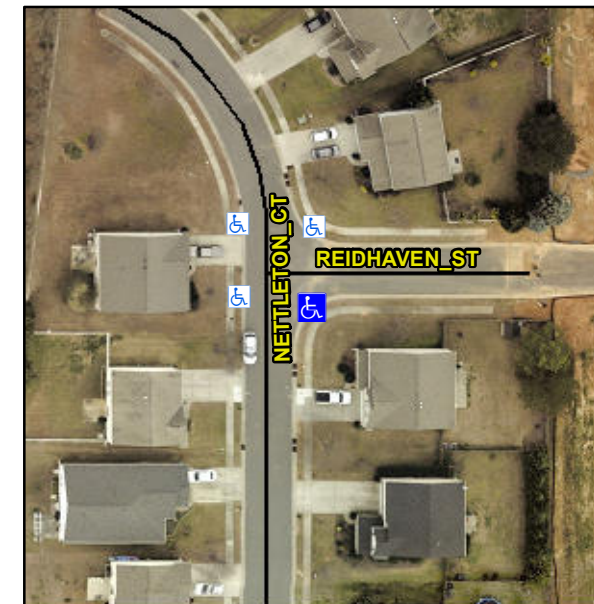
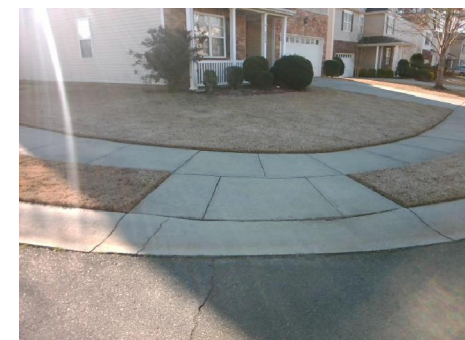
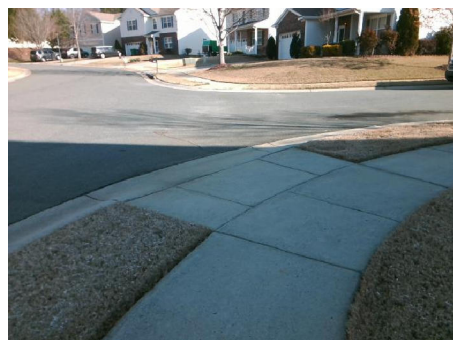
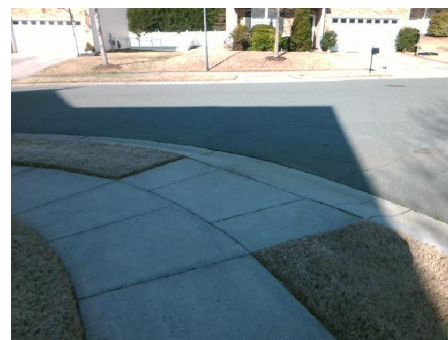
Compliance	Description	Data	Compliance	Description	Data
N/A	Ramp Length (in)	47.5	Yes	BlendTrans Slope (%)	4.6
No	Ramp Width (in)	44.5	No	BlendTrans XSlope (%)	4.7
N/A	Flare Type LT	N/A	N/A	Flare Type RT	N/A
N/A	Flare Slope LT (%)	N/A	N/A	Flare Slope RT (%)	N/A
N/A	Flare Traversable LT?	N/A	N/A	Flare Traversable RT?	N/A
N/A	Landing Length (in)	N/A	N/A	DWS Provided?	N/A
N/A	Landing Width (in)	N/A	N/A	DWS Contrast?	N/A
N/A	Landing Slope (%)	N/A	N/A	DWS Length (in)	N/A
N/A	Landing X Slope (%)	N/A	N/A	DWS Full Width?	N/A
N/A	Landing Curb? (Y/N)	N/A	N/A	DWS Offset (in)	N/A
N/A	Shared Landing?	N/A			
N/A	Gutter Ponding?	N/A	N/A	Gutter Slope (%)	N/A
N/A	Gutter Lip Ht (in)	N/A	N/A	Gutter X Slope (%)	N/A
N/A	Painted X Walk1?	No	N/A	Painted X Walk2?	No
	X Walk 1 Direction	To N		X Walk 2 Direction	To W
	X Walk 1 Width (in)	N/A		X Walk 2 Width (in)	N/A
	X Walk 1 Slope (%)	0.4		X Walk 2 Slope (%)	0.3
	X Walk 1 X Slope (%)	2.5		X Walk 2 X Slope (%)	3.2

N/A	Ramp inside XWalk1?	N/A	N/A	Ramp inside XWalk2?	N/A
	Road Slope (%)	1.0		Clear Space?	N/A
	Road X Slope (%)	3.4	N/A	Clear Space to XWalk (in)	N/A
N/A	Any Obstructions?	N/A	N/A	Storm Grate/Utility Hazard?	N/A
	Obstruction Type			Storm Grate/Utility Type	
		N/A			N/A
			Yes	Surface Condition? (G/P)	Good
			N/A	Curb Slope (%)	1.3

Remove & Replace Curb Ramp With Two New Directional Ramps or Equivalent.

R304.5.1, R304.5.3
