Access Compliance Report

Public Rights-of-Way (Curb Ramps)

Intersection ID: 20536	Main Street: CEDAR_HILL_DR	Cross Street: RED_HICKORY_LN	Location: NE
ADA ID: 70CC3C7B63C4	Ramp Type: Directional1	Initial Pass/Fail: Fail	Overall Compliance: No
		Severity Score: 10

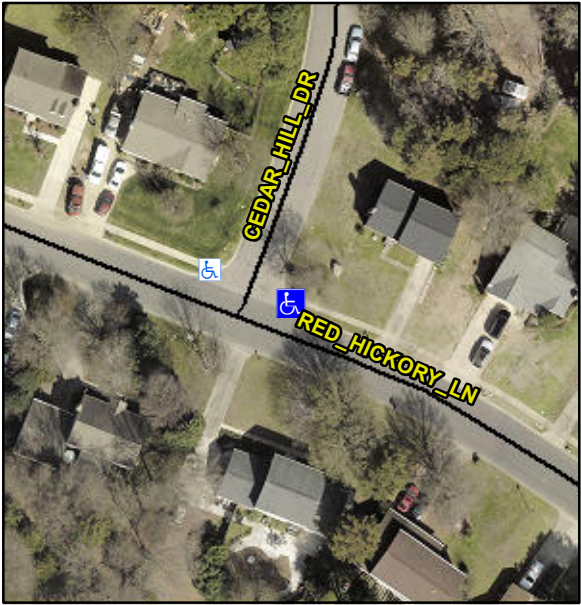
Possible Solutions:		Compliance	Description	Data	
	Remove & Replace Entire Ramp.		N/A	Ramp Length (in)	55.0	N/A
			No	Ramp Width (in)	44.0	N/A
			Yes	Ramp Slope (%)	2.7	N/A
			No	Ramp XSlope (%)	2.2	
			N/A	Flare Type LT	N/A	N/A
			N/A	Flare Slope LT (%)	N/A	N/A
			N/A	Flare Traversable LT?	N/A	N/A
			N/A	Landing Length (in)	0.0	N/A
			N/A	Landing Width (in)	0.0	N/A
			N/A	Landing Slope (%)	0.0	N/A
			N/A	Landing X Slope (%)	0.0	N/A
			N/A	Landing Curb? (Y/N)	N/A	N/A
			N/A	Shared Landing?	N/A	N/A
			N/A	Gutter Ponding?	0.0	N/A
			N/A	Gutter Lip Ht (in)	0.0	N/A
			N/A	Painted X Walk1?	No	
				X Walk 1 Direction	To W	
				X Walk 1 Width (in)	N/A	
				X Walk 1 Slope (%)	4.0	N/A
				X Walk 1 X Slope (%)	2.3	N/A
<p>Surveyor Notes:</p> <p>N/A</p>			N/A	Ramp inside XWalk1?	N/A	
			N/A	Any Obstructions?	N/A	
<p>PROW/ADA:</p> <p>R304.5.1, R304.5.3</p>				Obstruction Type

Yes	Surface Condition? (G/P)		Good
			N/A	Curb Slope (%)		3.6
Street 1 Name	CEDAR HILL DR					
Stop Condition-Street 1	StopSign					
Street 2 Name	N/A					
Stop Condition-Street 2	N/A					
Total Cost:	\$ 1600.00
