# Access Compliance Report

## Public Rights-of-Way

### (Curb Ramps)

Intersection ID: 9018	Main Street: GRANT_ST	Cross Street: LAKEWOOD_AV	Location:	N
ADA ID: 70E0559AB269	Ramp Type: Perp	Initial Pass/Fail: Fail	Overall Compliance: No	Severity Score: 60
Codes/Mitigation Info/Possible Solution		Field Measurements/Component Compliance

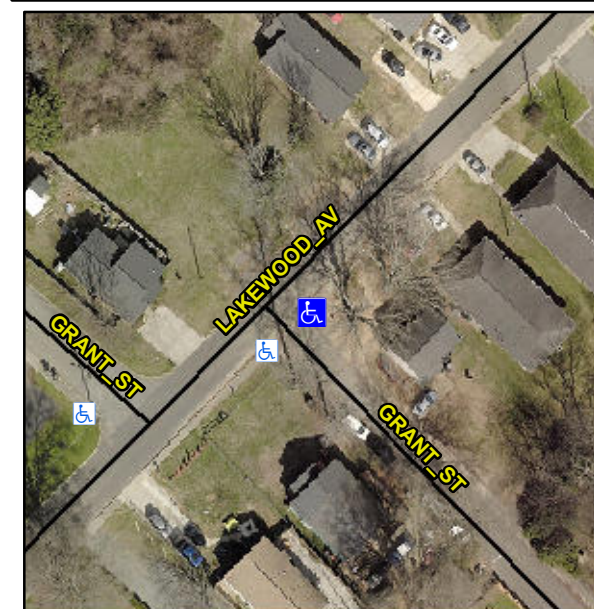
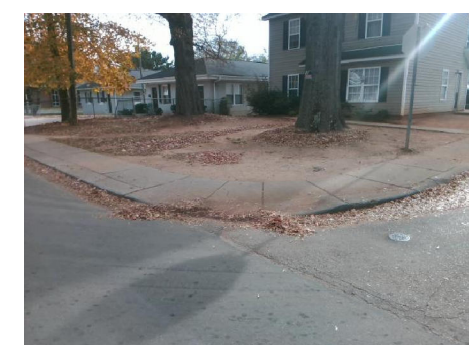
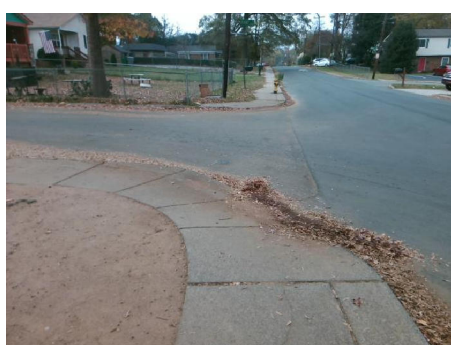
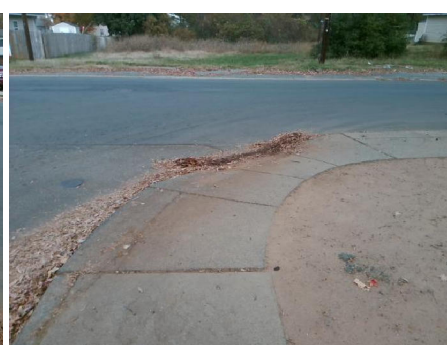
Compliance	Description	Data	Compliance	Description	Data
N/A	Ramp Length (in)	53.0	No	Ramp Slope (%)	17.7
No	Ramp Width (in)	24.0	Yes	Ramp XSlope (%)	1.7
N/A	Flare Type LT	N/A	N/A	Flare Type RT	N/A
N/A	Flare Slope LT (%)	N/A	N/A	Flare Slope RT (%)	N/A
N/A	Flare Traversable LT?	N/A	N/A	Flare Traversable RT?	N/A
N/A	Landing Length (in)	N/A	N/A	DWS Provided?	N/A
N/A	Landing Width (in)	N/A	N/A	DWS Contrast?	N/A
N/A	Landing Slope (%)	N/A	N/A	DWS Length (in)	N/A
N/A	Landing X Slope (%)	N/A	N/A	DWS Full Width?	N/A
N/A	Landing Curb? (Y/N)	N/A	N/A	DWS Offset (in)	N/A
N/A	Shared Landing?	N/A			
N/A	Gutter Ponding?	Yes	N/A	Gutter Slope (%)	N/A
N/A	Gutter Lip Ht (in)	N/A	N/A	Gutter X Slope (%)	N/A
N/A	Painted X Walk1?	No	N/A	Painted X Walk2?	N/A
	X Walk 1 Direction	To SW		X Walk 2 Direction	N/A
N/A	X Walk 1 Width (in)	N/A	N/A	X Walk 2 Width (in)	N/A
	X Walk 1 Slope (%)	0.1		X Walk 2 Slope (%)	N/A
	X Walk 1 X Slope (%)	4.8		X Walk 2 X Slope (%)	N/A

N/A	Ramp inside XWalk1?	N/A	N/A	Ramp inside XWalk2?	N/A
	Road Slope (%)	N/A	N/A	Clear Space?	N/A
	Road X Slope (%)	N/A	N/A	Clear Space to XWalk (in)	N/A
N/A	Any Obstructions?	N/A	N/A	Storm Grate/Utility Hazard?	N/A
	Obstruction Type			Storm Grate/Utility Type	
		N/A			N/A
			Yes	Surface Condition? (G/P)	Good

**Remove & Replace Entire Ramp.**

**R304.5.1, R304.2.2**
