Access Compliance Report

Public Rights-of-Way

(Curb Ramps)

Intersection ID: 50638	Main Street: RUBY_VALLEY_RD	Cross Street: BLUE_GROVE_RD	Location: NE
ADA ID: 70E644F3C19C	Ramp Type: Perp	Initial Pass/Fail: Fail	Overall Compliance: No
Severity Score: 22.5			
Codes/Mitigation Info/Possible Solution		Field Measurements/Component Compliance

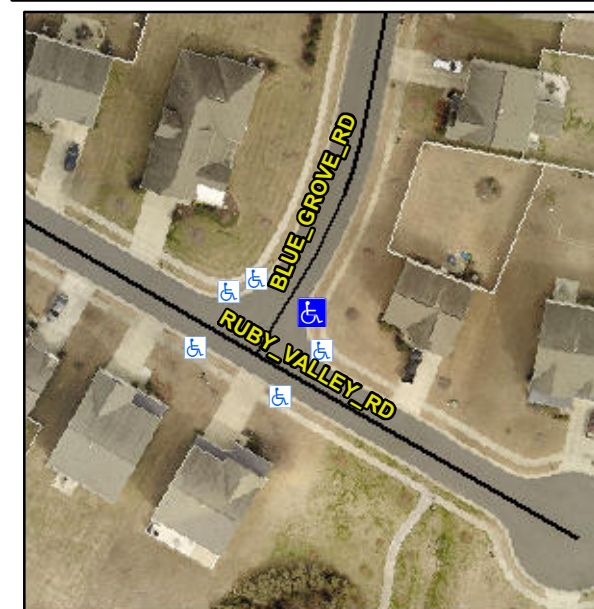
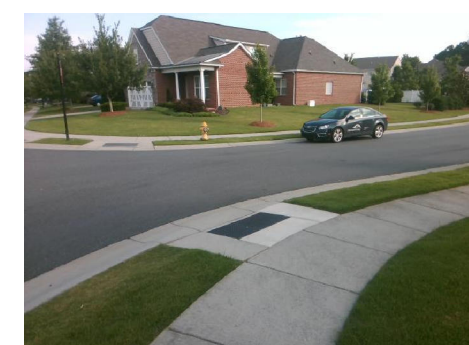
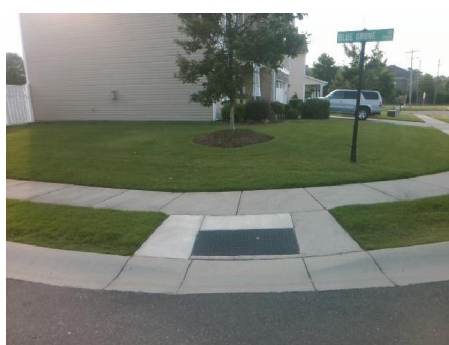
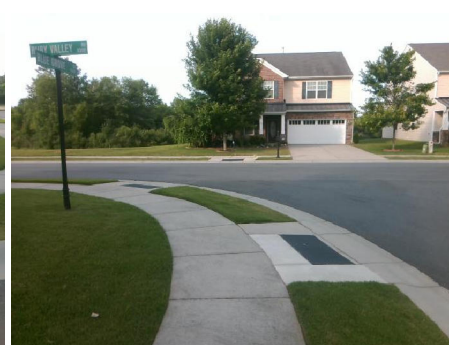
Not Found, R304.5.1, R304.2.2, R304.5.3

Compliance	Description	Data	Compliance	Description	Data
N/A	Ramp Length (in)	47.0	No	Ramp Slope (%)	10.2
No	Ramp Width (in)	47.0	No	Ramp XSlope (%)	2.5
N/A	Flare Type LT	N/A	N/A	Flare Type RT	N/A
N/A	Flare Slope LT (%)	N/A	N/A	Flare Slope RT (%)	N/A
N/A	Flare Traversable LT?	N/A	N/A	Flare Traversable RT?	N/A
N/A	Landing Length (in)	N/A	N/A	DWS Provided?	N/A
N/A	Landing Width (in)	N/A	N/A	DWS Contrast?	N/A
N/A	Landing Slope (%)	N/A	N/A	DWS Length (in)	N/A
N/A	Landing X Slope (%)	N/A	N/A	DWS Full Width?	N/A
N/A	Landing Curb? (Y/N)	N/A	N/A	DWS Offset (in)	N/A
N/A	Shared Landing?	N/A			
N/A	Gutter Ponding?	N/A	N/A	Gutter Slope (%)	N/A
N/A	Gutter Lip Ht (in)	N/A	N/A	Gutter X Slope (%)	N/A
N/A	Painted X Walk1?	No	N/A	Painted X Walk2?	N/A
	X Walk 1 Direction	To NW		X Walk 2 Direction	N/A
N/A	X Walk 1 Width (in)	N/A	N/A	X Walk 2 Width (in)	N/A
	X Walk 1 Slope (%)	0.9		X Walk 2 Slope (%)	N/A
	X Walk 1 X Slope (%)	2.2		X Walk 2 X Slope (%)	N/A

N/A	Ramp inside XWalk1?	N/A	N/A	Ramp inside XWalk2?	N/A
	Road Slope (%)	N/A	N/A	Clear Space?	N/A
	Road X Slope (%)	N/A	N/A	Clear Space to XWalk (in)	N/A
N/A	Any Obstructions?	N/A	N/A	Storm Grate/Utility Hazard?	N/A
	Obstruction Type			Storm Grate/Utility Type	
		N/A			N/A
			Yes	Surface Condition? (G/P)	Good

Remove & Replace Entire Ramp.
